# Impact echo scanning for imaging of grout defects to mitigate corrosion in post-tensioned bridge ducts

**A.T. Balkema, G. Westers, L.D. Olson, Y. Tinkey & A. Gibson**  
*Olson Engineering, Inc.*

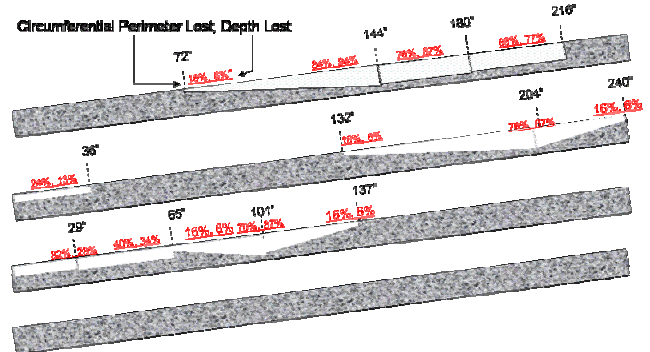
Modified Styrofoam rods (10.16 cm or 4 inches in diameter) were inserted into the ducts before grouting to form internal voids with sizes ranging from small to almost full diameter voids. Figure 3 shows a Styrofoam rod being inserted into the top duct of the north wall. A wire (1/8 inch or 3 mm in diameter) was bent to form a leg for the Styrofoam rod so that the foam would be positioned on the roof of the duct, which simulates the real world grout defects formed by air and water voids. Smaller defects were glued directly to the roof of the duct since they were too thin for the wire leg. The defect sizes are presented in Table 1 in terms of their circumferential perimeter and depth lost. The defect designs are presented in Table 1 for all four ducts in the South web wall. The actual percentage of circumferential perimeter and diameter depth lost due to the defect are shown in the underlined numbers placed directly above the defects in Figure 4.

Figure 4. Actual Grout Defect in the South Wall in 10.16 cm (4 in) Metal Ducts

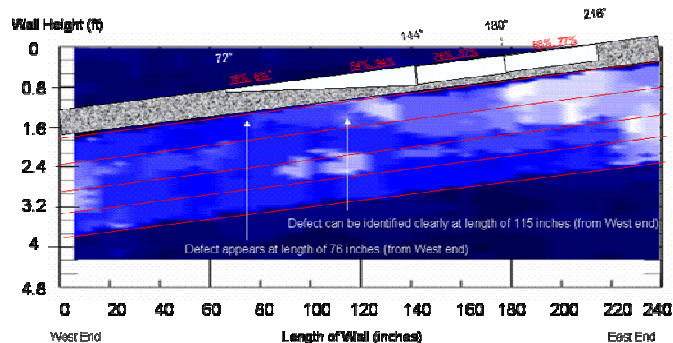
South Wall – Top Duct: The IE results from the South Wall with the actual defect design of the top duct placed above the IE results of the top duct are shown in Figure 5. The results are interpreted to indicate that the grout defect started to appear at a length of 1.93 m (76 in) and becomes clearly evident at length of 2.92 m (115 in) from the west end of the duct. The location that the defect starts to appear corresponds to void with 11% depth lost or 20% circumferential perimeter lost. The location that the grout defect become more evident corresponds to void with 59% depth lost or 57% circumferential contact diameter lost. The dominant frequency of the fully grouted duct is approximately 6.4 kHz, resulting in an apparent impact-echo thickness of 28.37 mm (11.17 in.). The dominant frequency shifted to approximately 5.37 kHz for an empty duct, which corresponds to an apparent impact-echo thickness of 34.0 cm (13.4 in.). This is a relatively large thickness shift of over 30% compared to the nominal thickness of the wall. The interpretation of the impact-echo scanner results, however, shows a

downshift in frequencies from lengths of 5.49 to 6.1 m (216 to 240 in), indicating voids at duct locations where no discontinuities were intentionally placed. It is likely that grout did not flow into the east end due to the big voids in front of it. Radiographic tests will be performed in the future to verify the design versus actual conditions of the simulated defects.

Figure 5. IE Results from the South Wall with Actual Design Defects of Top Duct

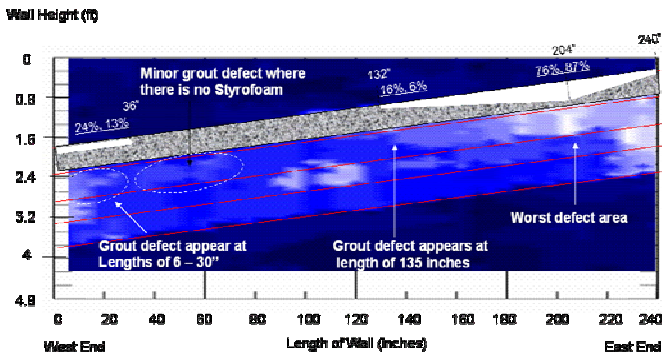
South Wall – Second Duct from Top: Review of Figure 6 shows that there are three grout defect zones. The first grout defect zone correlates with the end defect (13% depth lost or 24% circumferential lost). The second defect zone shows minor grout problem from lengths of 0.91 – 1.67 m (36 – 66 in) from the west end of the duct. However, there is no actual defects placed in this area. Radiography is required to confirm the realization of defect designs. The third defect zone appears at a length of 3.35 m (132 in) which corresponds to defect of 9% in depth lost or 18.5% in circumferential lost. The most apparent grout defect appears at a length of 5.18 m (204 in) corresponding to the location of the largest Styrofoam in the duct (87% depth lost or 76% circumferential perimeter lost). Similar to the results from the top duct, the interpretation of the impact-echo scanner results, however, shows a downshift in frequencies from lengths of 5.18 to 6.1 m (204 to 240 in), indicating major voids at duct locations where actual defect shape tapers down toward the east end. It is likely that grout did not flow in to the east end due to the big voids in front of it.

Figure 6 – IE Results from the South Wall with Actual Design Defects of Second Duct

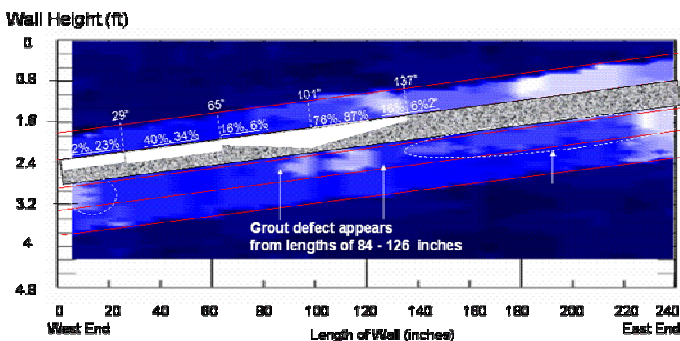
**South Wall – Third Duct from Top:** Figure 9 shows three zones of grout defects. The first area is located at the west end where Styrofoam Defect ID# 3 (see Table 1) is in place. However, the IE results show that the duct is fully grouted between lengths of 0.45 – 2.13 m (18 – 84 in) from the west end where there are actual Styrofoam defects placed in these locations. The grout defect appears again between lengths of 2.13 – 3.2 m (84 – 126 in). The starting location of the second defect zone corresponds to actual defect of 49% depth lost or 48% circumferential lost. The end location of the defect zone corresponds to an actual defect of 30% depth lost or 34% circumferential perimeter grout contact lost. The interpretation of the impact-echo scanner results, however, shows a downshift in frequencies from lengths of 3.48 – 6.1 m (137 to 240 in), indicating minor to major voids at duct locations where no actual Styrofoam defect is in place. Radiography is required to confirm the actual final location of Styrofoam voids.

Figure 7. IE Results from the South Wall with Actual Design Defects of Third Duct

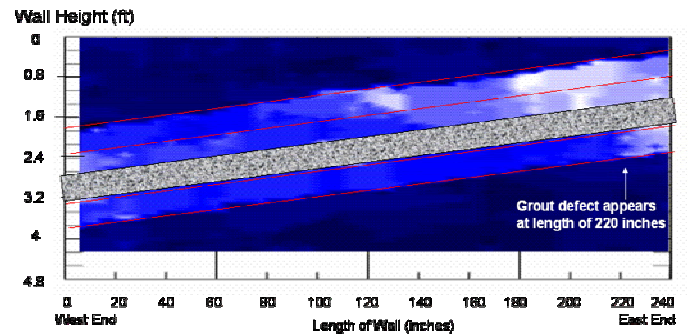
**South Wall – Bottom Duct:** There are no Styrofoam voids placed inside the bottom duct and it is fully grouted. However the interpretation of the impact-

echo scanner results shows a downshift in frequencies from a length of 5.59 m (220 in) to the east end, indicating major voids. IE results of the bottom duct compared to the actual design of the bottom duct are shown in Figure 8. Review of Figures 5 – 8 shows similar results toward the east end of the duct regardless of the presence of the Styrofoam void. It is likely that the grout levels off toward the east end of the ducts due to duct inclinations.

Figure 8. IE Results from the South Wall with Actual Design Defects of Bottom Duct (Completely Grouted Duct)

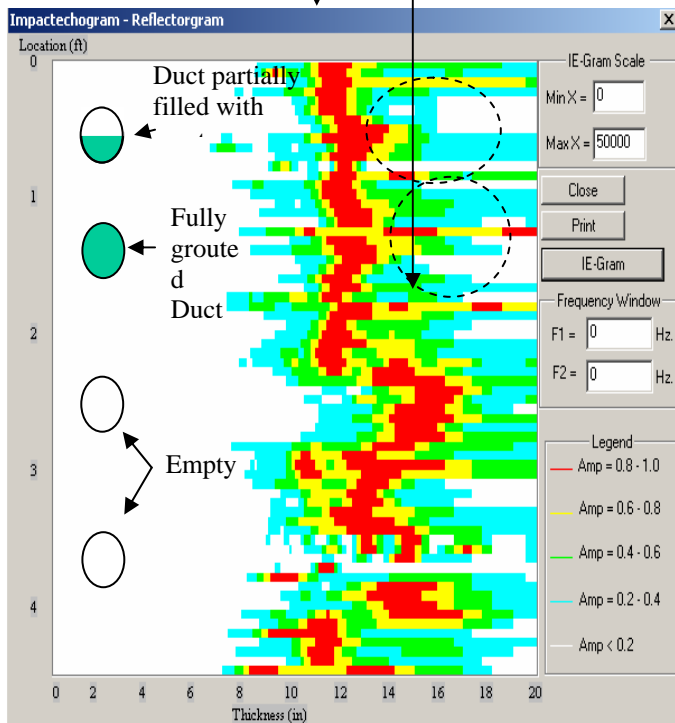
This section discusses Impactechogram results from impact echo scanning on a cable stayed post-tensioned bridge. The typical thickness of the wall section was 30 cm (12 in.) with four steel ducts inside. The ducts were first located with ground penetrating radar. Impact-echo scanning was used to evaluate the internal grout condition of four ducts in a box girder which were also destructively investigated. The IE scans were performed in such a way as to cross all four ducts vertically and along each duct laterally. Destructive coring tests and further inspection using a videoscope were performed to observe the actual condition of all four ducts. From the videoscope results, the top duct was partially filled with water, the second duct was fully grouted and the third and the bottom ducts were completely empty (see Figure 9). An impactechogram from vertical impact echo scanning across the four ducts is presented in Fig. 9. The picture inside the empty duct (bottom duct) captured from a videoscope is shown in Figure 10. Review of Fig. 9 shows that the Impact Echo results can be used effectively to identify internal conditions of the grouted ducts in the fully grouted and empty condition. However, the impact-echo scanning was

not able to identify the water-filled condition. This is likely because compressional waves can travel through water resulting in conditions more similar to those of the fully grouted ducts. More experimental

Fig. 9 – Impactechogram from IE scanning across ducts of known conditions in a Cable Stayed Bridge

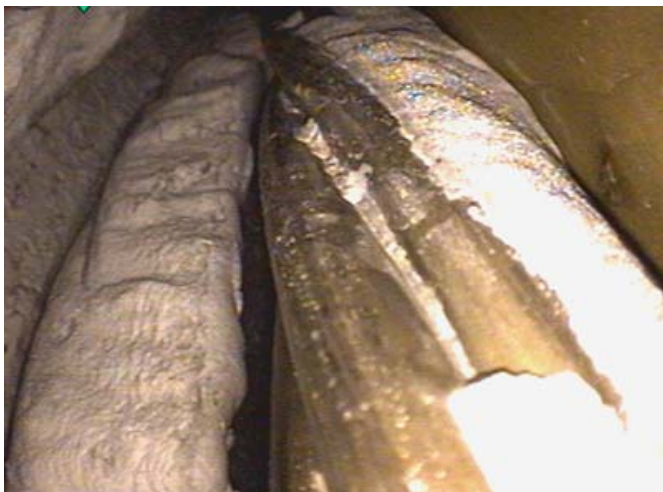
Figure 10. Voids inside the Bottom Duct (from Videoscope)
