# **SHIP CRASH INTO THE RIVER DANUBE RAILWAY BRIDGE IN KREMS – MONITORING AND ALARM SYSTEM FOR THE DAMAGED STRUCTURE**

Peter Furtner  
VCE, Austria

## **Abstract**

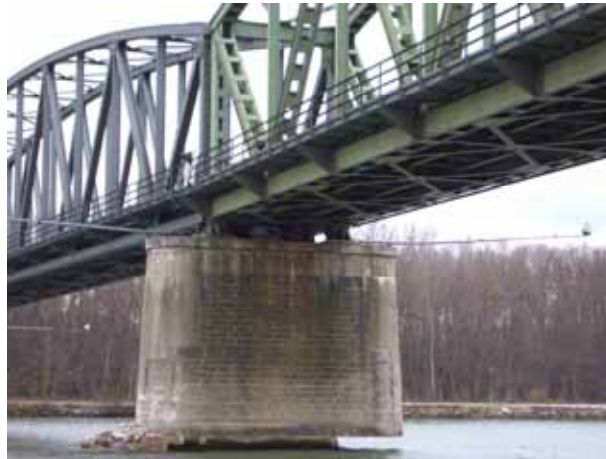
In the early morning of December 17, 2005 a ship loaded with more than 3500 tonnes of iron ore traveling upstream the Danube River crashed into the center pier of the railway-bridge in Krems - Austria. The pier was sheared off above the water surface and moved 2.17 meters upstream (Figure 1).

The submerged part of the pier stub was checked by divers. They noticed numerous cracks at the pier stub. Due to the check results, failure mechanisms were assumed. First: Failure of the substructure which is announced by an inclination. Second: Brittle fracture of the remaining pier shaft due to the loads from the structure.

Figure 1. Damaged pier

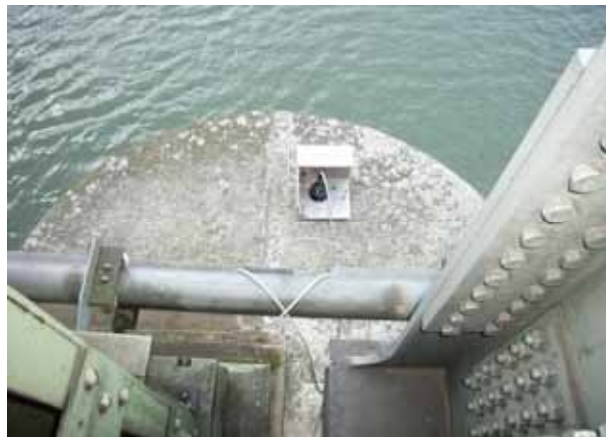
- Damaged pier, upstream (Figure 2).
- Damaged pier, downstream.
- At both superstructures supported by pier 5 at a distance of approx. 20 m of the pier.

Figure 2. Sensor on the damaged pier

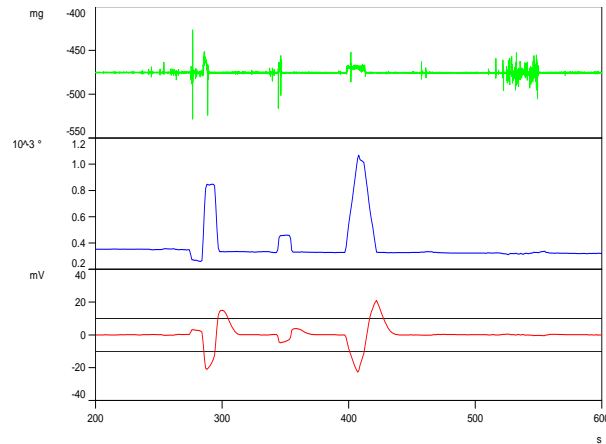
Figure 3. Test of the monitoring system

After installation the proper function of the system was tested by manual inclination of the sensors. Figure 3 shows the results of this test:

- The raw signal
- The inclination
- The trigger criterion with the threshold values

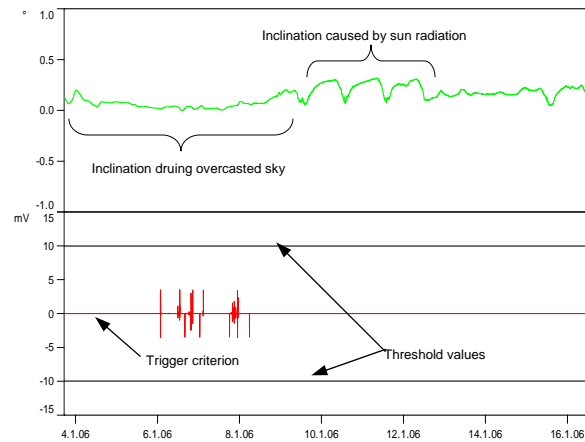
All recorded measuring data were saved on site and subsequently evaluated and graphically processed. Figure 4 shows typical results of permanent monitoring. The influence of insolation on temperature expansion and the pier inclination influenced by it can be clearly recognized.

On January 31, a sensor was knocked over during the cutting of the cable trough. This led to an exceeding of all threshold values. The slight change in position of the sensor during the resetting was expressed by a displacement in the measurement record.

Figure 4. Typical monitoring results from the damaged pier

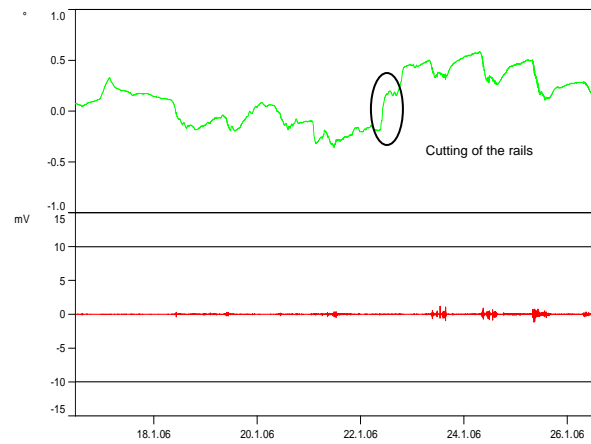
Figure 5: Inclination during cutting of the rails
