STRUCTURAL HEALTH MONITORING OF LINDQUIST BRIDGE

Abstract

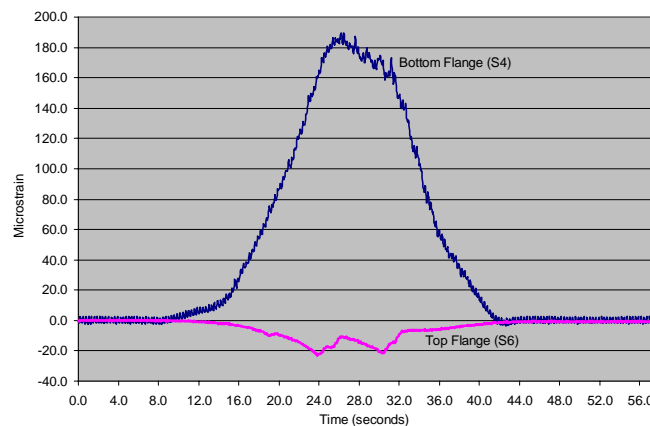
The top and bottom strains at the mid-span of the north girder are plotted against time in Figure 6 as the test vehicle traveled at a crawling speed. It can be seen in this figure that the magnitude of the tensile strains in the bottom flange are always larger than the magnitude of the compressive strains in the top flange. This confirms the presence of the composite action between the deck slab and the girders.

Figure 6. Longitudinal strains at mid-span in North girder.

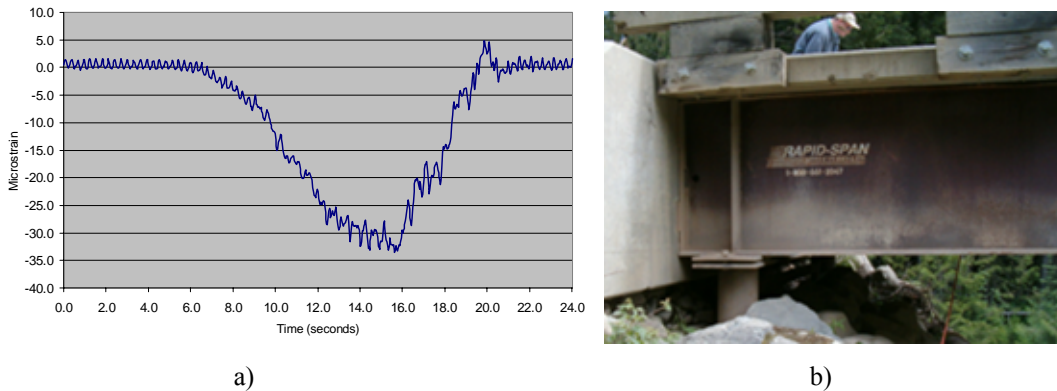
In order to investigate this further in the 2006 monitoring, a strain gauge was installed on the bottom flange of the south girder at Section A-A (Figure 3), which is located only 100 mm from the edge of the pile support. In a truly simply supported bridge, the strains at this location would have been tensile and very small in magnitude. The bottom flange strains induced by the test vehicle moving at a crawling speed near the support are plotted in Figure 7a while a photograph of a girder support is shown in Figure 7b. It can be seen in Figure 7a that the strains at the bottom girder flange near the support are negative, i.e. compressive. The maximum magnitude of these compressive strains is about $34 \mu\epsilon$ and is not small compared to the maximum tensile girder strain at the mid-span which is about $200 \mu\epsilon$ (Figure 6). Thus, it is confirmed that the girders of the Lindquist Bridge are not simply supported, and have substantial bearing restraint.

Figure 7. a) Bottom flange strains at Section A-A; b) Girder support.

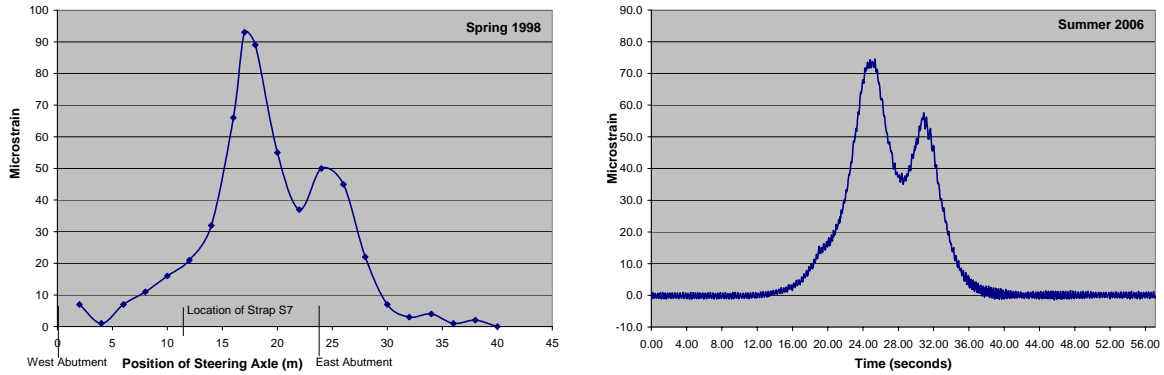
In order to compare the strain readings in the strap to the 1998 measurements, the ratios are determined using the vehicle loads in both tests. The ratio of the loads on the 1st tandems of the 1998 and 2006 test vehicles is 1.31, and the corresponding ratio for the 2nd tandems is 0.90. Using the ratios, the expected strain readings in the 2006 test are 71 and $56 \mu\epsilon$. It can be seen in Figure 8b that the maximum strain in Strap S7, induced mainly by the 1st tandem of the test truck was about $73 \mu\epsilon$ and the strain induced by the 2nd tandem was $57 \mu\epsilon$. This suggests that under the same loads, the strap strains have hardly increased since 1998.

a) Figure 8. Strain in Strap S7: a) Spring 1998; b) Summer 2006. b)

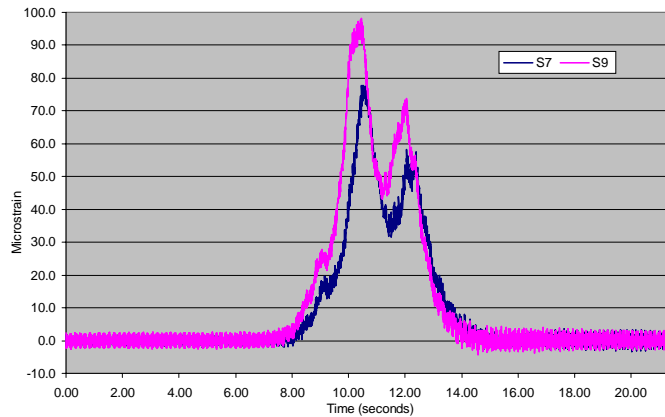
Figure 9. Strains in Straps S7 and S9 with test vehicle traveling at about 15km/hr.

The plots of the strains in Straps S7 and S9 during the medium and fast speed tests are similar to Figure 9. It can be seen that the strains in the strap closer to a cross-frame (ie. S7) are consistently lower than those in the other strap, thus confirming that the top horizontal component of the cross-frames also participates in restraining the deck slab in the transverse direction.

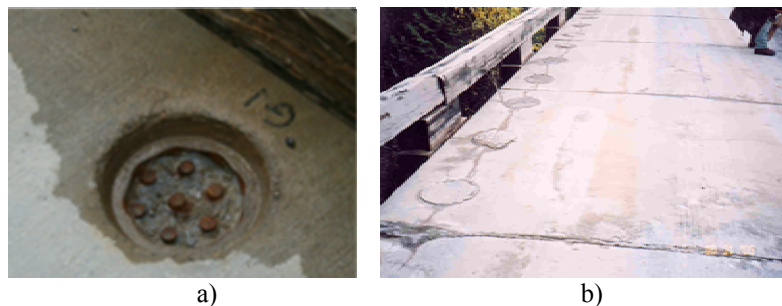
The precast deck slab of the Lindquist Bridge is made composite with steel girders by means of shear bulkheads consisting of 250 mm diameter corrugated galvanized steel pipe bulkheads. Each bulkhead contains seven shear studs (Figure 10a) and site-mixed grout. The shear bulkheads are also referred to as grout pockets. The grout poured in the shear bulkhead and in transverse joints between the precast panels was mixed at site using heated water. The installation of the grout was not of the highest quality, and was found missing in one location as shown in Figure 10a, in which the heads of the studs are exposed.

During the years 1999 and 2003, longitudinal cracks developed between these shear bulkheads (Figure 10b). It is important to note that such cracks were not observed in the fatigue tests on the same type of deck slab panel as employed in the Lindquist Bridge [7].

Figure 10. a) Exposed shear studs in one shear bulkhead; b) Longitudinal cracks between shear bulkheads

A possible explanation of why these longitudinal cracks were formed involves the lateral forces experienced by the bulkheads. As seen in Figures 8 and 9, the tensile forces in straps are highly localized and are highest when a truck axle is directly above a strap. As a result, the top flanges of the girders are pushed out laterally at the locations of the

At a cursory glance, the longitudinal cracks in the precast panels above the girders (Figure 10) give a cause for concern about the stability of the cantilever portion of the unreinforced deck slab, lying beyond these cracks and the anchorage of the steel strap. However, upon reflection, it becomes clear for several reasons that the cantilever portions of the deck slab have little danger of being detached from the main deck slab.

A careful inspection by several professional engineers confirmed that the longitudinal cracks stop at the shear bulkhead and do not appear to go around the bulkheads when viewed from the top of the deck. If the longitudinal cracks were developed by transverse negative moments (ie. due the weight of the vibrating timber guard rail), the cracks would have gone around the perimeter of the shear bulkheads.

The shear bulkheads are formed with corrugated steel pipes (see Figure 10a) which provide a mechanical connection in the vertical and longitudinal directions between the corrugated pipe and the surrounding concrete. The cantilever portions of the deck slab beyond the longitudinal cracks cannot break off without engaging the corrugated steel pipe. Since only a single-tire wheel of the most eccentric vehicle can come on the cantilever portion of the slab, for the L75 design vehicle, the maximum weight of this wheel is 32 kN. As seen in Figure 11a, there are two 25mm diameter x 625 long steel reinforcing bars installed midway along the exterior edge of each interior deck slab panel and project approximately 125 mm beyond the cracks. These rods are provided to secure the timber guard rails to the deck slab. In the event that longitudinal cracks between the shear bulkheads are joined by circumferential cracks around the bulkheads, these rods would be required to restrain the detached portions of the deck slab. The transverse moments in the deck slab due to live loads are expected to reach their peak at the edge of the girder flange, beyond where their intensity should remain nearly constant up to the location of the girder web. It was found that the total transverse moment intensity at the edge of the top flange due to factored dead loads and factored 32 kN wheel, including 40% impact, is 9.9 kN.m per 3 metre length of the panel. The factored moments of resistance of the deck provided mainly by the two 25 M bars varies from zero at the extremities of the bars to 15.3 kN.m per 3 metre length of the deck slab. It is therefore concluded that there is little danger of the cantilever portion of the deck slab from being detached.

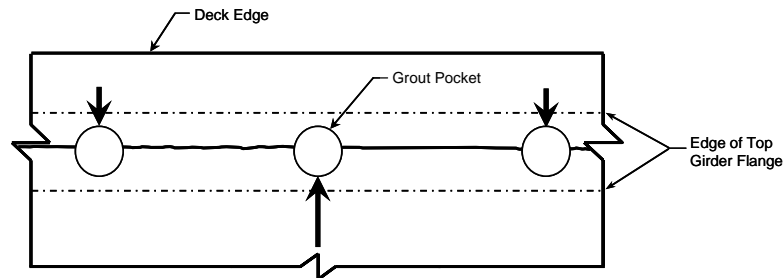
shear bulkheads by forces of different magnitude. In Figure 11, a case is shown where only one shear bulkhead is subjected to a lateral force acting towards the outer edge of the bridge, while the adjacent bulkheads are not subjected to any lateral forces. Clearly, in such a case, the transverse tensile stresses will crack the unreinforced slab at the section with the smallest area of cross-section, which is the longitudinal section between the shear bulkheads.

Figure 11. Example of only one shear bulkhead subjected to lateral force.

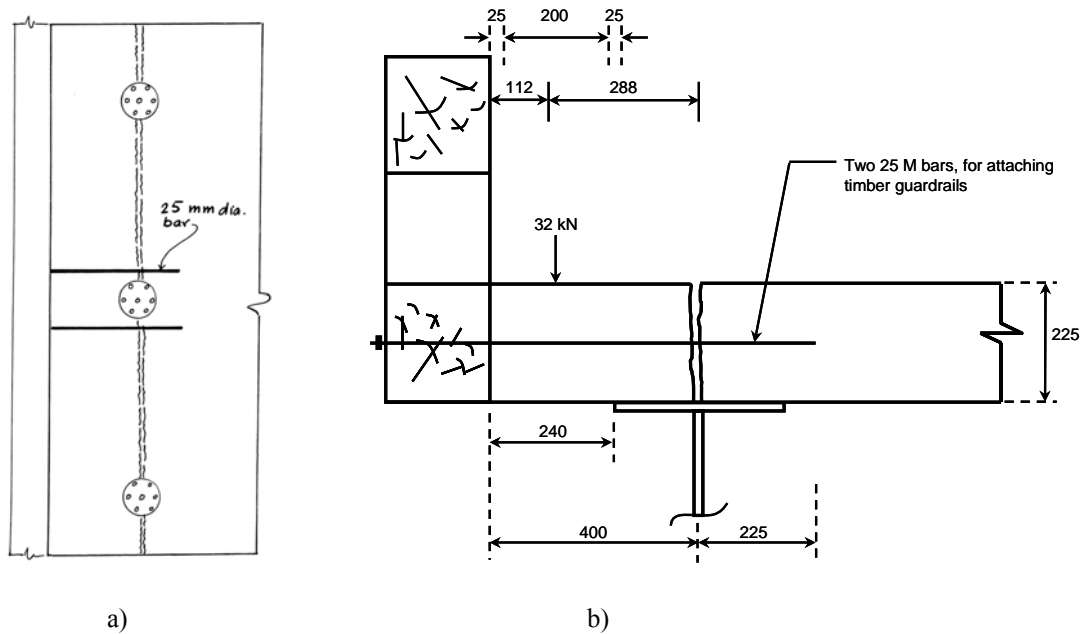
Figure 11. a) Cracks in precast panels over girder; b) A single-tire wheel of the most eccentric vehicle
