LONG-TERM PERFORMANCE MONITORING OF GFRP-REPAIRED BRIDGE COLUMNS

Abstract

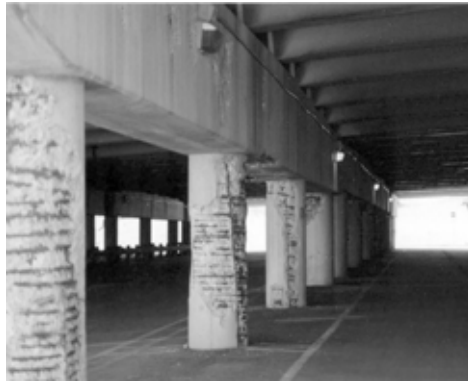
Figure 1. Damaged columns of a highway bridge.

The damage was mostly concentrated at the bents that are directly below the expansion joints. The joint sealant had deteriorated with time, allowing the de-icing salt solution to soak the reinforced concrete bents. Accumulation of this solution at the bent top and its continuous flow downward along the columns resulted in deterioration of concrete as well as corrosion of steel. The columns were also exposed to salt attacks from the cars using the area under the bridge as a parking lot. The structure is also subjected to usual Toronto environmental effects that include freeze thaw cycles, wet dry cycles, temperature variations, etc. The spiral steel in the columns and tie steel in the beams severely corroded as a result of this exposure. The expansive forces thus generated caused the cover concrete in both columns and girders to be severely delaminated.

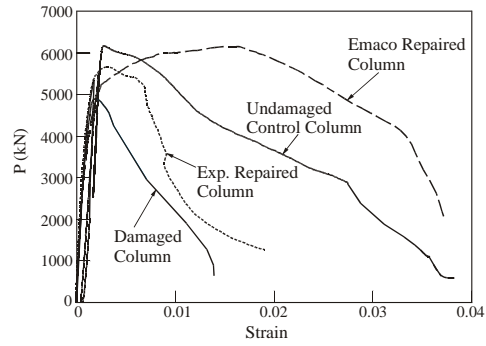
It can be seen from Fig. 2 that the damaged column had about 20% lower strength and substantially lower ductility and energy dissipating capacity than the undamaged control column. The corrosion rendered the spiral steel completely ineffective in the damaged columns. Pitting corrosion of spiral reduced its effectiveness for confinement and caused its rupture at relatively small column strain.

Behaviour of repaired specimens was significantly better than that of the damaged unrepaired specimen. The axial load carrying capacity of the Emaco-repaired specimen was as large as that of the control undamaged column and its ductility and energy dissipation capacity were substantially better. The Exp-repaired column did not display as good a performance as the Emaco-repaired column. This is due to the fact that at large strains the plastic sheet of the formwork used in the Exp-repaired column opened out and engaged the fibre wrap at both ends, causing large local strain and premature failure of the wrap and the column.

Figure 2. Behaviour of columns under axial load.

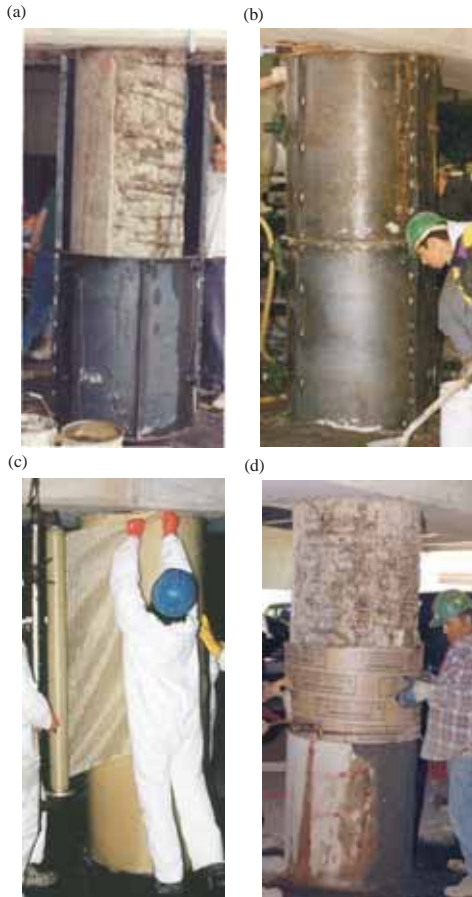
Figure 3. Various steps in column repair.

Column 1 was repaired with expansive concrete grout using steel formwork (Figs. 3a and 3b). The thickness of the expansive concrete cover around the column was about 50 mm. The formwork was removed about twenty hours after grouting and the column was wrapped with a thin polyethylene sheet and then two layers of GFRP with glass fibres aligned in the circumferential direction (Fig. 3c). The polyethylene sheet was used as a barrier between the new concrete and the GFRP and was not expected to affect the column behaviour. Three days after the grouting, the column was instrumented with six strain gauges installed on the FRP in the circumferential direction. Two gauges each, 180° apart, were installed at mid height, 750 mm above and 750 mm below the mid point.

Column 3 was repaired with EMACO-based rheoplastic mortar which did not require and formwork (Fig 3d). A protective epoxy coating was applied six days later followed by the GFRP wrapping. The strain gauges were applied to this column eight days after grouting/plastering.

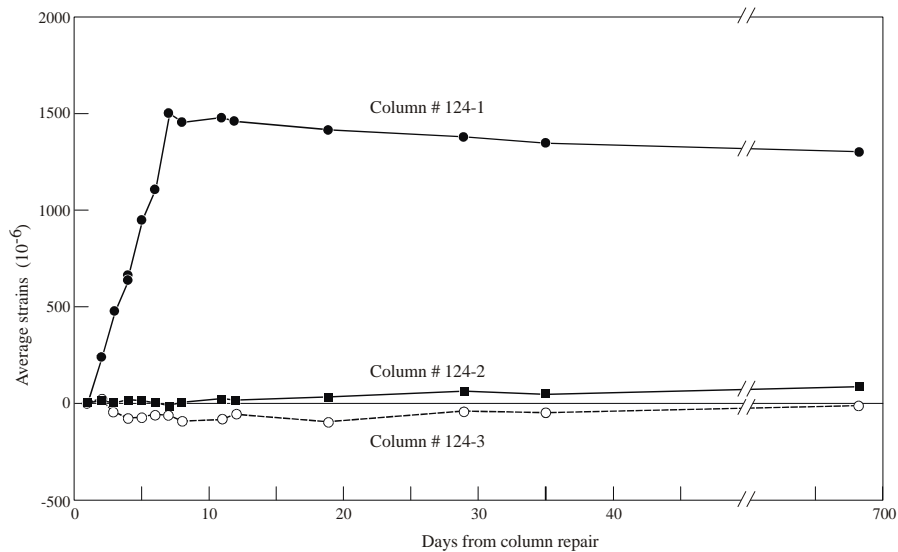
Figure 4 shows variation of lateral strain with time from the field columns. As expected, Column 1 showed substantial expansion while no significant lateral strain was measured in FRP in Columns 2 and 3. The maximum expansion in Column 1, approximately 0.16%, was observed ten days after grouting and represents about 10% of GFRP rupture strain. Lateral GFRP strain in the three columns remained fairly constant for about two years indicating stable expansive cement behaviour and no significant creep of GFRP. Recording of strain data was terminated about two years after the repair.

Figure 4. Lateral strain in GFRP in repaired columns.

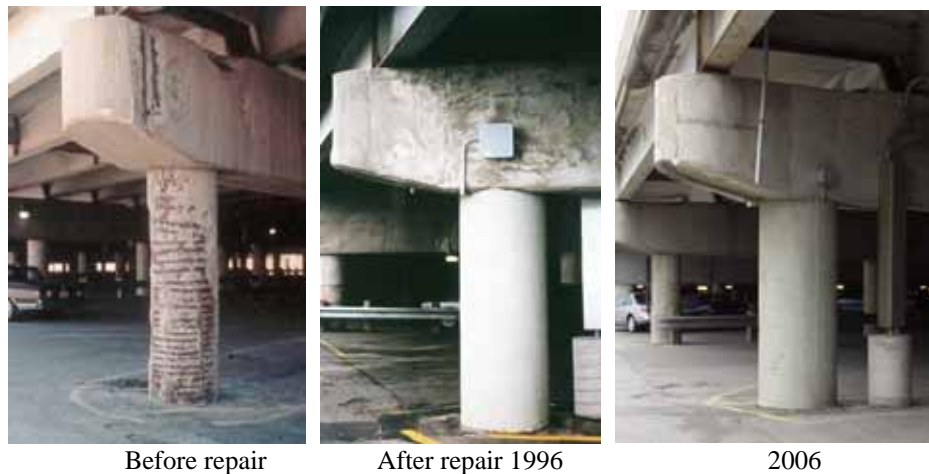
Field data on strain and corrosion rate and physical inspection over eleven years indicated a sound performance of the retrofit techniques used for the columns. Figure 5 shows Column1 before repair, soon after repair and in 2006. No deterioration was observed in any of the columns and risk of future corrosion has also reduced. There has also been no need to repeat the repair process in any of the columns repaired more than eleven years ago. In this first GFRP repair exercise, a thin polyethylene sheet was used in some columns as a barrier to separate new mortar or concrete from the GFRP to avoid any possible adverse effects of alkalis on the performance of GFRP in the long term. Since then, extensive testing has shown excellent long-term performance of GFRP sheets under alkaline environment (4, 9-11). Future repairs using GFRP can thus be carried out without the use of barriers. Although the presence of the barrier is not

Figure 5. Columns before and after repair.
