# IRT survey for the quality control of FRP reinforced r.c. structures

by P. Corvaglia\*, A. Largo\*

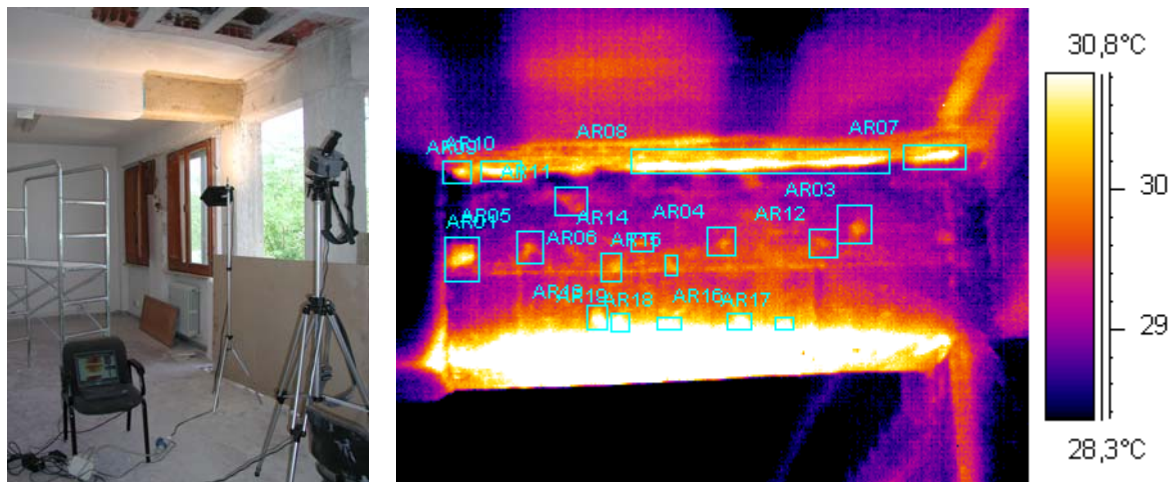
In the following (Fig. 5, indoor and Fig. 6, outdoor) two examples of thermograms of the GFRP reinforced structure are presented; especially in Fig. 5 a lot of defects of different shapes and dimensions were identified.

This was probably caused by an improper use, during the placement of the FRP sheets, of the stiff rubber roller (which should help the adhesive to completely penetrate through the fibres of the fabric) and of the aluminium roller with a worm screw (which should help to completely eliminate air bubbles formed during application). All the defects were classified as Type 3.

**Fig. 5** Indoor IRT survey of an r.c. structure reinforced with GFRP sheets

However, in this case, considering the number and distribution of defectiveness all along the reinforced area, even if every single defect could be separately repaired, it was considered advisable to completely remove and reapply the entire FRP system.

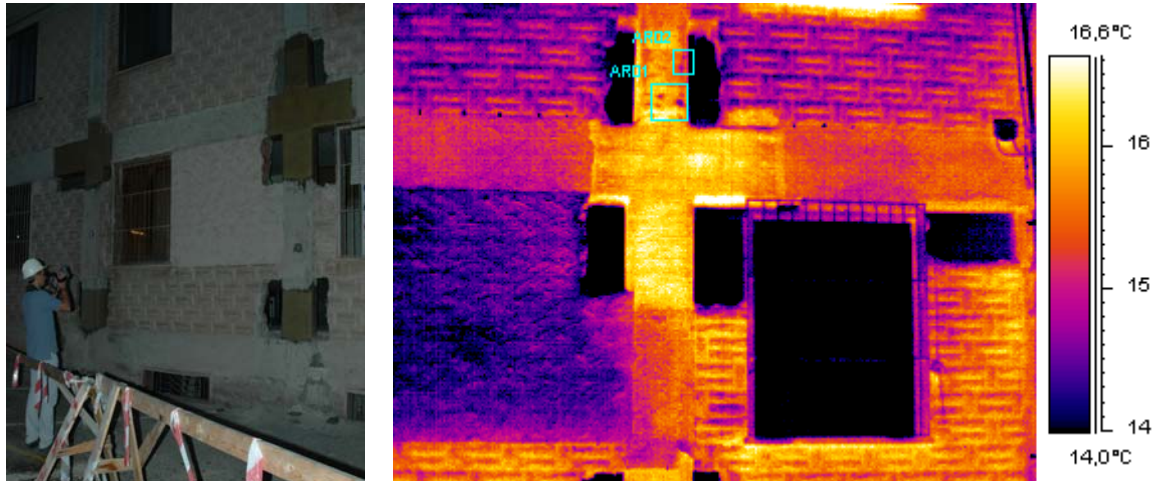
In Fig. 6, a thermogram recorded during an outdoor IRT survey is reported; for the whole part of the GFRP reinforced beam – column joint a perfect adhesion between the glass fibres sheets and the concrete substrate can be pointed out. However, the IRT procedure was able to identify some small bonding defects on the upper part of the joint. This kind of defect, generally caused by air entrapment, have a lower thermal inertia with respect to the GFRP – concrete interface; for this reason they appear hotter than the surrounding materials during the heating phase (Fig. 5), and colder during the cooling phase (Fig. 6).

**Fig. 6** Outdoor IRT survey of an r.c. structure reinforced with GFRP sheets

Although the defects were classified at the limit between a Type 2 and a Type 3 defect, in case of contact – critical FRP application (e.g. columns or joints wrapped for confinement), low – pressure epoxy injection can be a valuable method for repairing.

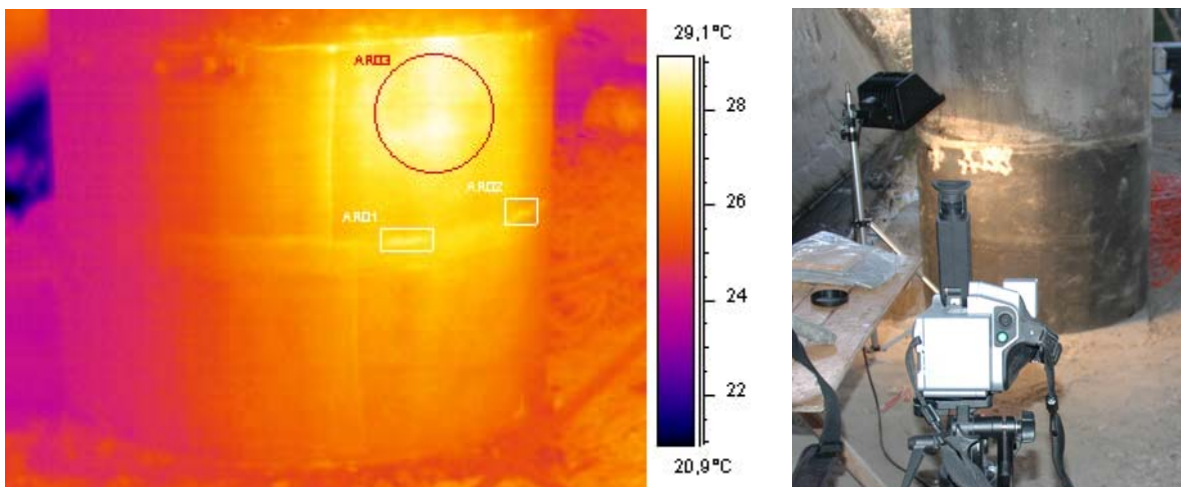
**Fig. 7** IRT survey of an r.c. structure reinforced with CFRP and SRP materials

In Fig. 7 two types of defect are described.

The first type (in white square in Fig. 7) is caused by the longitudinal joining of two CFRP sheet. When applying multiple plies of FRP sheets for columns wrapping, or when two strips need to be joined longitudinally, it is necessary to create an overlapping of at least 20 cm. Overlapping is not necessary for the width of the fabric because the different strips of fabric can simply be applied one next to the other. Nevertheless, for the presented case study, the strategy of overlapping the two CFRP strips, along the width, for 3 cm, was adopted (this is also evidenced in Fig. 8). According to the IRT survey results, it can be concluded that this kind of approach can cause a “step effect” resulting in a lot of air inclusion all along the column diameter. However, these kind of defects are very often characterized by a low aspect ratio and can be easily repaired using low – pressure epoxy injection.

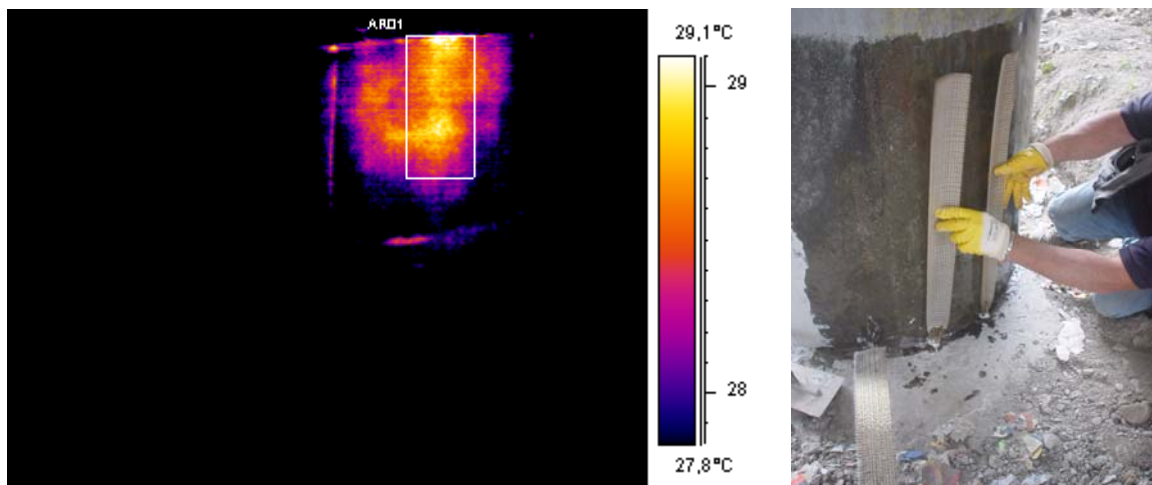
**Fig. 9** Application of SRP reinforcement

The second type of defect (evidenced in the red circle in Fig. 7 and in the white rectangle in Fig. 9, left) is most probably due to the presence of the SRP reinforcement (applied between the concrete and the CFRP sheet, as described in Fig. 9, right) and can be classified as a Type 4 defect. However, considering that the debonded zone is located in a reinforced area designed as “witness panel” (i.e. not resulting from the design of the reinforcement but strengthened only to perform other tests, like direct pull – off test), it can be easily repaired with low – pressure epoxy injection.

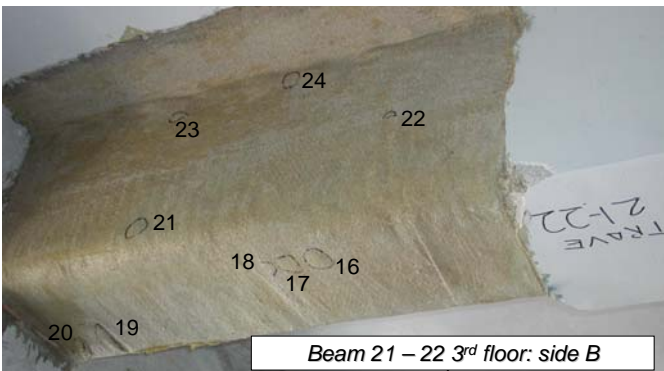
<p>Beam 21 – 22 3<sup>rd</sup> floor: side B</p>		1			✓		Method 2
		2			✓		Method 2
		3		✓			Method 1
		4		✓			Method 1
		5		✓			Method 1
		6		✓			Method 1
		7		✓			Method 1
		8		✓			Method 1
		9			✓		Method 2
		10		✓			Method 1
		11		✓			Method 1
		12		✓			Method 1
		13			✓		Method 2
		14		✓			Method 1
		15			✓		Method 2
		16			✓		Method 1 <sup>2</sup>
		17			✓		Method 1 (note 2)
		18		✓			Method 1 (note 2)
		19			✓		Method 1 (note 2)
		20			✓		Method 1 (note 2)

21			✓		Method 2
		22		✓			Method 1
		23		✓			Method 1
		24		✓			Method 1
<b>INDICAZIONI</b>							
Considering the number and distribution of defectiveness all along the reinforced area, it may be advisable to completely remove and reapply the entire FRP system. However, the reparation of every single defect could be also accepted.
