STRUCTURAL HEALTH MONITORING OF GFRP REINFORCED BEAM AT VETERAN AFFAIRS BROOKSIDE CEMETERY

Abstract

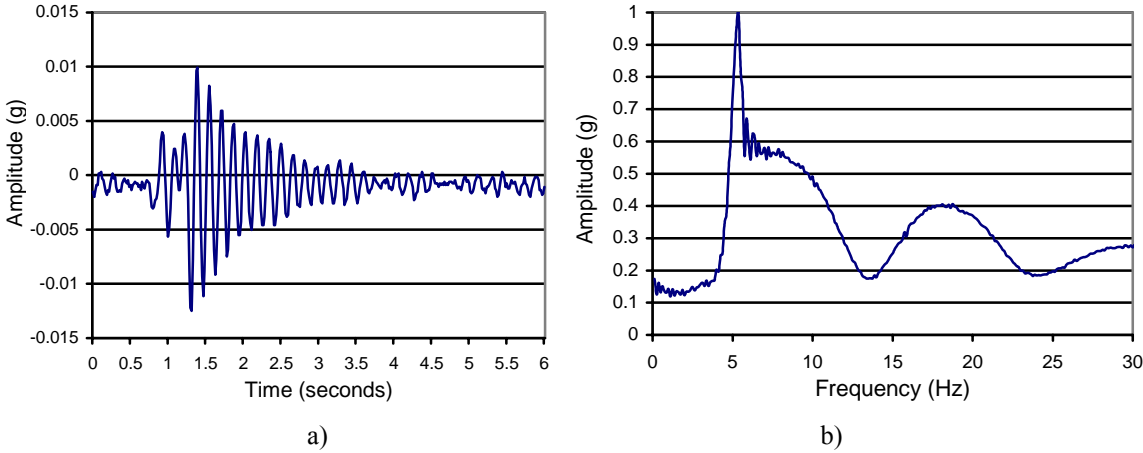
Figure 6. Frequency response of concrete beam in August 2004
a) Accelerometer response; b) Natural frequency

The dynamic response of the beam was measured using the embedded accelerometer. The beam was excited at mid-span with a 68 kg mass and the readings were recorded with a data acquisition system. The frequency of the beam was then determined by taking the fast Fourier transform (FFT) of the accelerometer response. The accelerometer response and frequency of the beam after installation of the markers is presented in Figure 6. In July 2006, accelerometer readings using the same excitation were recorded (Figure 7). As seen in Figures 6 and 7, the frequency of the beam in August 2004 was approximately 5.4 Hz; while in July 2006, the

frequency was 4.5 Hz. This reduced frequency is caused by the decreased stiffness of the beam as the concrete has cracked over time.

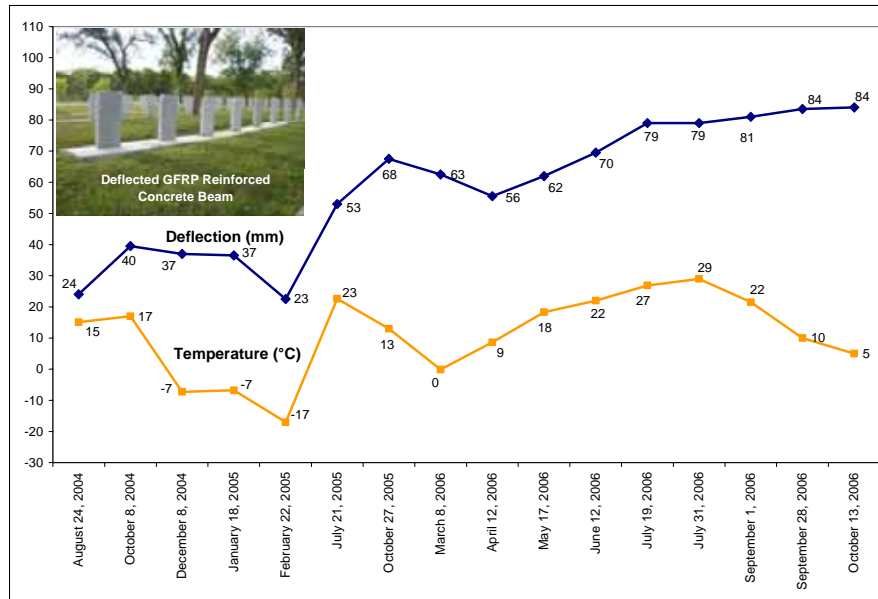
Figure 8. Periodic measurements of deflection at mid-span and temperature

Over the monitoring period of 30 months, the deflection of the beam at mid-span has been of interest. During each inspection, the deflection of the beam was measured using a theodolite. It is important to note that the trial beam has a very shallow depth due to design constraints and because no gravel bed was placed below it during its installation. Hence, the beam continued to deflect due to creep of the concrete. As the deflection of the beam increased to 84 mm over a two year period (Figures 8), remedial work was discussed to raise the beam to improve the aesthetics.

After discussions with Veteran Affairs Canada, City of Winnipeg Cemeteries, and Concrete Restoration Services, a plan of action was agreed upon to raise the beam. This plan of action involved using four hydraulic jacks at middle third points to lift the beam.

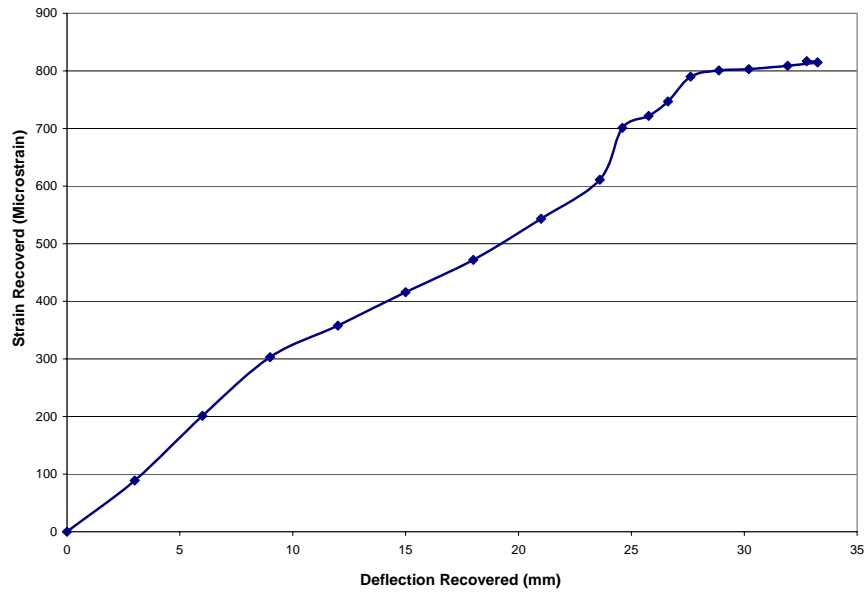
Figure 11. Strain in the midspan internal reinforcement during lifting of the beam

During the lifting of the beam, both internal and external sensors were used to monitor its behaviour. The strains on the top surface of the concrete and on the internal GFRP reinforcement bars were recorded. A graph of the strain recovered in the reinforcement at mid-span during the lifting of the beam is shown in Figure 11. A Pi gauge and a Demec gauge were installed externally to measure the strain on the top surface of the concrete. The deflection of the beam was measured using a theodolite and a linear variable differential transducer (LVDT).

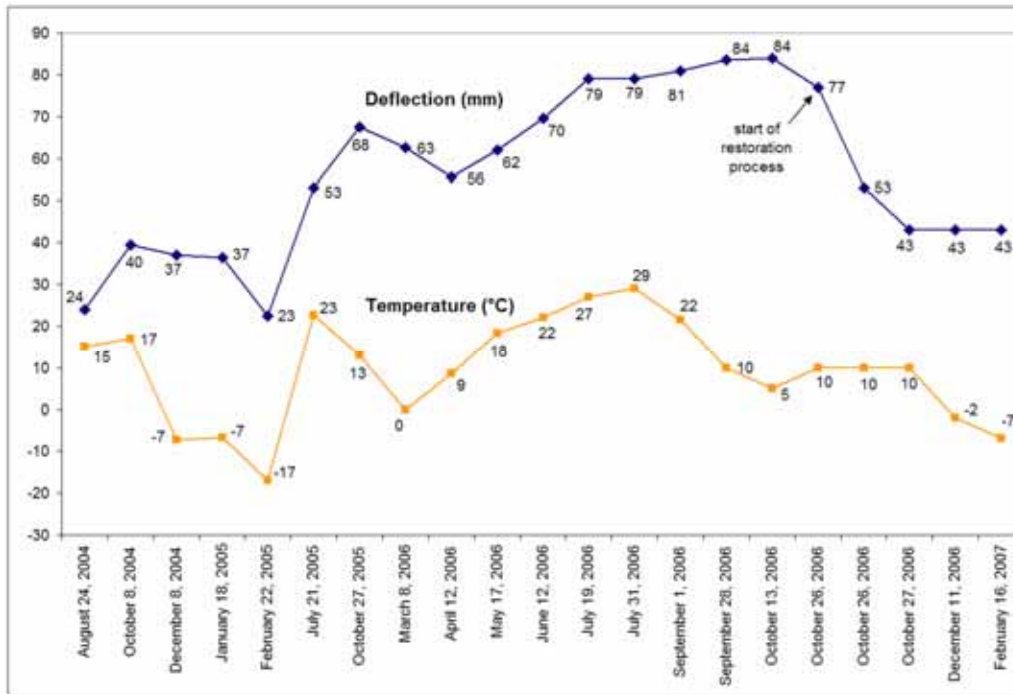
Figure 12. Periodic deflection and temperature measurements up to the completion of remedial work

After completion of the remedial work, the deflection of the beam was decreased to 43 mm as seen in Figure 12. Thus, the beam was raised by 41 mm from the maximum deflection of 84 mm.

The performance of the beam has been periodically monitored after the remedial work was completed. The deflection of the beam has not changed in the four months after it was raised as seen in Figure 12. The trial beam is safely carrying the marker and its own weight and there is ample reserve ultimate strength. The restoration effort will keep the deflections small. The GFRP pin connections are working very well between the markers and the trial beam. The durability of the beam is excellent. As part of the restoration effort, it is anticipated that the deflection of the beam will be further reduced to 20 mm.
