# Performance based bridge design by infusion

H. M. Aktan

**ABSTRACT:** The durability condition of concrete highway bridges in Michigan, USA is discussed. A methodology for durability condition assessment is proposed. The life-cycle performance based design of bridges is a process that is being developed within the last decade. In this process, the bridge durability performance expectation (optimal performance) is understood as a goal. A feedback control process is advised for bridge design where the feedbacks are developed utilizing the differences between optimal and measured performance. In this context, health monitoring and its infusion to the design process needs to be an essential ingredient in performance based design. This paper will discuss the SHM infusion process for unremarkable concrete highway bridges.

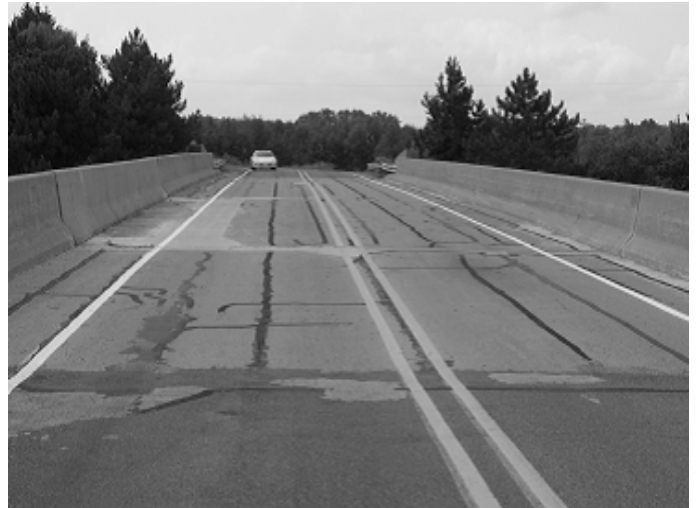
Figure 2. Bridge deck distresses and repair

The original wearing surface of inspected pre-1960 bridges was either concrete or bituminous. In most cases, the wearing surfaces had been replaced with an overlay of PC concrete or latex modified concrete or asphalt. When asphalt is used as the wearing surface, a water proofing membrane is often placed over the beams. In all cases, longitudinal deck cracking and distressed joints over the abutments and piers were common to all bridges. On most of the pre-1960 bridge decks, crack sealants were applied over the longitudinal cracks. Crack sealants appeared to be effective over wide cracks (Figure 2). Nevertheless, some of the large width longitudinal cracks were sealed; however, there were significant length of deck cracks that were not watertight. The concrete wearing surface on some of the bridge decks was patched with polymer concrete, but the cracking along the patch border allowed water penetration. Concrete wearing surface was placed with a wire mesh reinforcement thus, susceptible to delamination and spalling observed as potholes. Expansion joints over the abutments and the piers exhibited extensive distress. The continuous concrete bridge deck (in order to eliminate the joints over the piers) showed substantial cracking above

the piers, especially a continuous transverse crack directly over the pier. The drainage systems of the older bridges were ineffective.

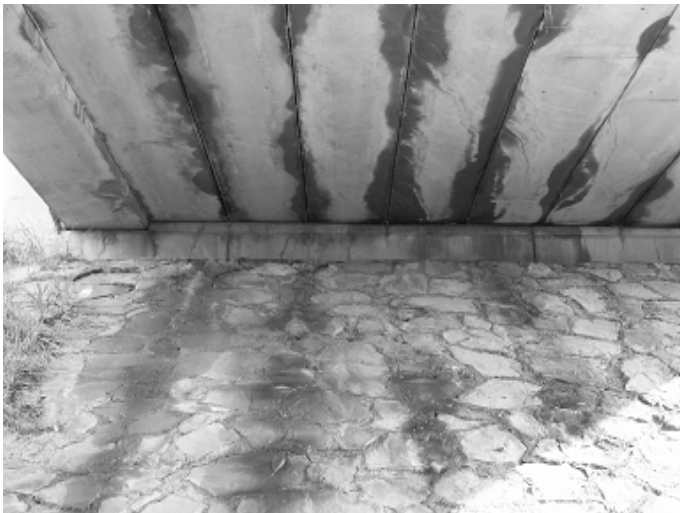
Figure 5. Moist beams, leaky joints, and moisture on stub abutment

All the pre-1960's bridges showed signs of prolonged exposure to moisture along beam edges and beam soffits. Small shear-keys used in old bridges could not be visually inspected. Overnight rains sometimes helped to identify the leaky joints (Figure 5). Moisture on stub abutment was a clear indication

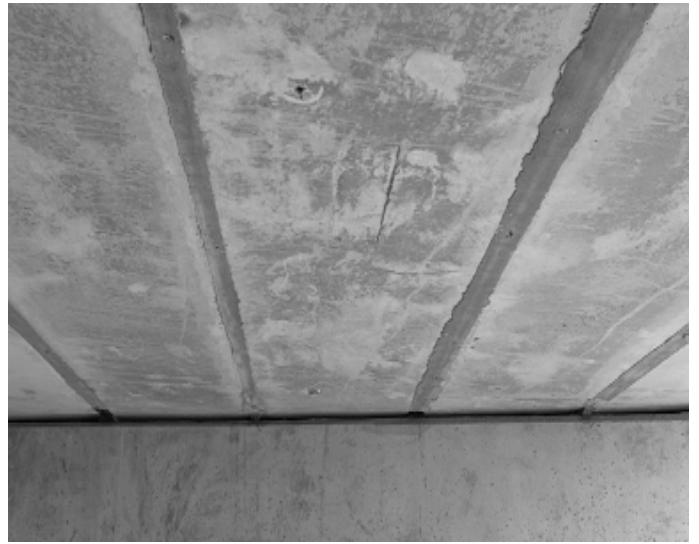
Figure 12. Moisture on beam soffits and post 1985 design shear keys

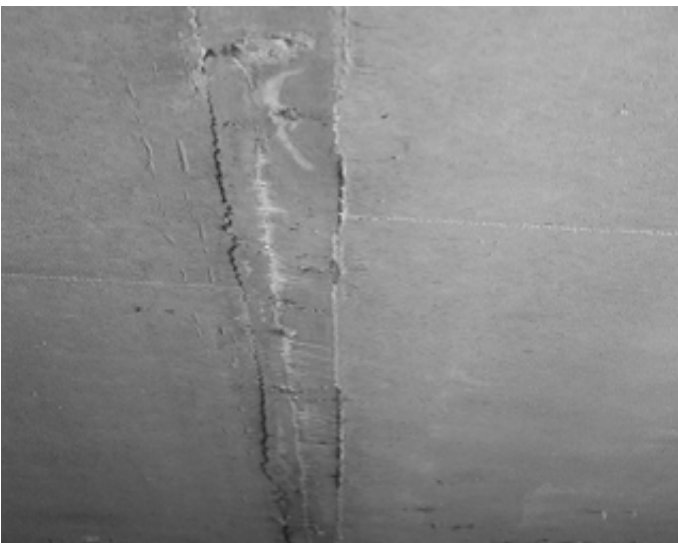
Figure 11. Efflorescence on the cracked post 1985 design shear key

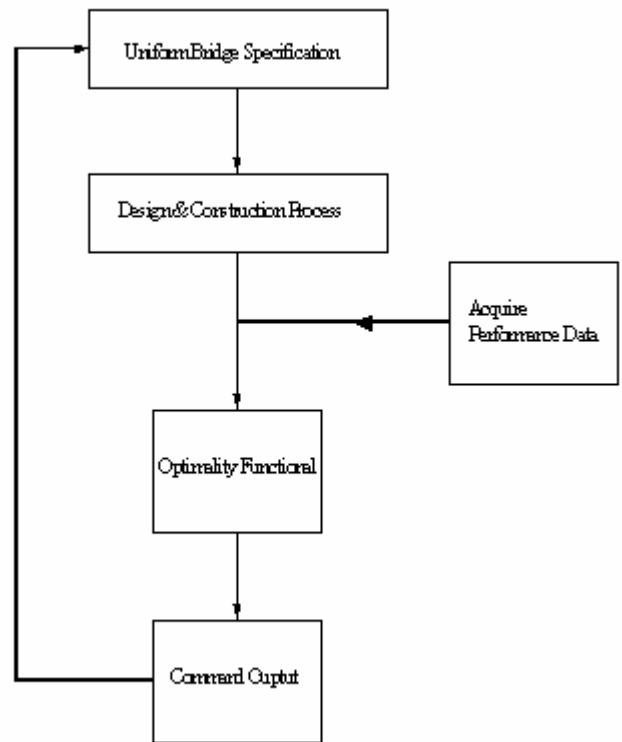
Figure 13. Design infusion by optimal feedback control

Basis for design by infusion can be most simply described as a linear regulator control process. In this process, the goal is to establish a control input so as to drive the plant from an initial state to a constant final state. In this process, the reference state (bridge service life) is assumed constant. The state is described as the specifications that control design and construction (uniform specifications). External actions such as the exposure, live loads are acquired as part of the state. The optimal control is determined based on acquired performance data and user selected gains in order to keep the plant response (deterioration rate) constant also as presented by Aktan & Aktan (1999). A simplified block diagram of the control process is shown in Figure 13. In this process, all functions are known or well defined except the acquisition of performance data. The primary work performed in this study deals with defining the performance assessment process by utilizing the health monitoring data. In presenting this process, a previous study on causes and cures for PC I-beam end deterioration (Aktan et al. 2002).
