MONITORING OF HERITAGE STRUCTURES AND HISTORICAL MONUMENTS USING LONG-GAGE FIBER OPTIC INTERFEROMETRIC SENSORS – AN OVERVIEW

Branko Glisic
SMARTEC, Switzerland

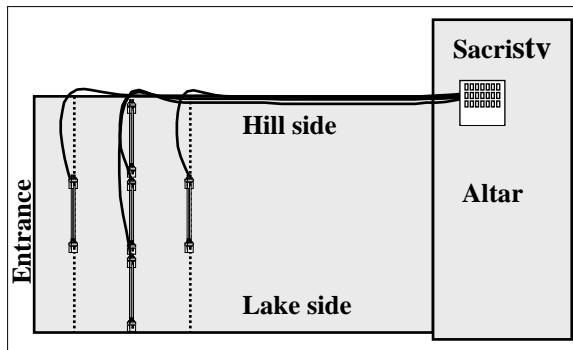
Figure 2. Position of the sensors, top view

Since the static system of the church and the evolution of the crack openings are not very well known, the decision was made to install ten sensors to monitor the cracks and the curvature variations of the vault. The sensors are 30-50 cm long and are attached to both sides of the vault using L-brackets. All optical connections are joined in the sacristy and the sensors are measured regularly without the need to install scaffoldings in the church, which is still in use. The position of sensors is presented in Figures 1 and 2. The sensor installation was carried out in just one day and the sensors are barely visible to the uninformed observer. A view of the installed sensors is presented in Figure 3.

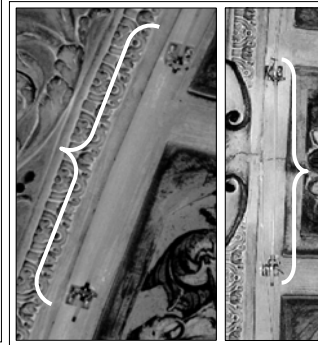
Figure 3. View of sensors installed in the vaults

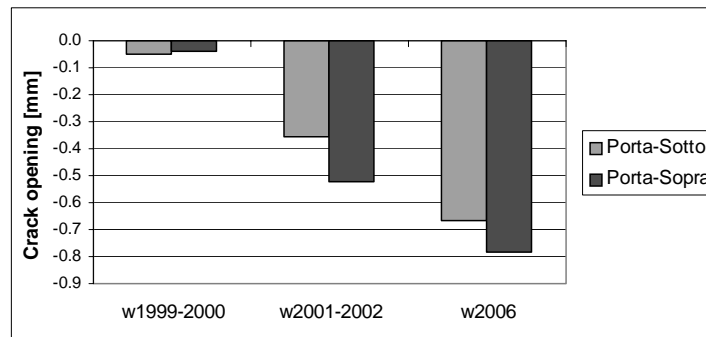
Figure 4. Example of results collected on San Vigilio church

The results shown in the figure confirm closing of the observed crack. This indicates slow redistribution of the loads inside the vault that is subject to further investigation.

Due to budget restrictions and since the deformations were expected to evolve smoothly, it was decided against installing a reading unit permanently in the church. Instead, measurement campaigns of at least one week were carried out at intervals of about three months. This monitoring program allows the observation of the deformations due to the daily and seasonal temperature variations. An example of results obtained by two of the sensors is shown in Figure 4.

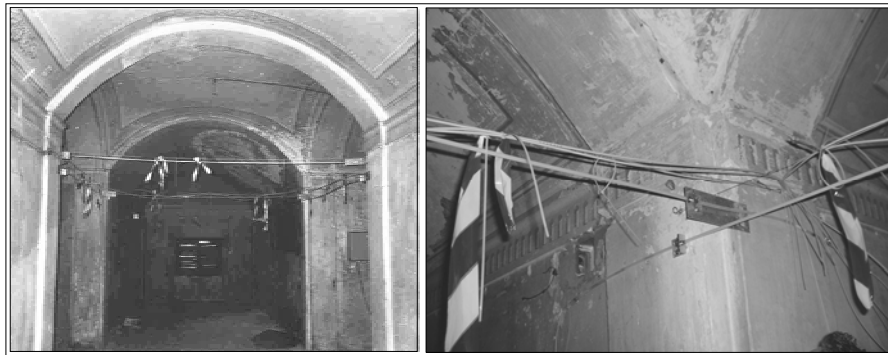
Figure 6. Long-gauge sensors installed between the walls in main corridors (courtesy of Tecniter)

Optical fibre sensors were mainly used as extensometers installed between the walls, orthogonal to the corridor axes, but shorter sensors were also used for crack monitoring. The sensors installed between the walls are shown in Figure 6.

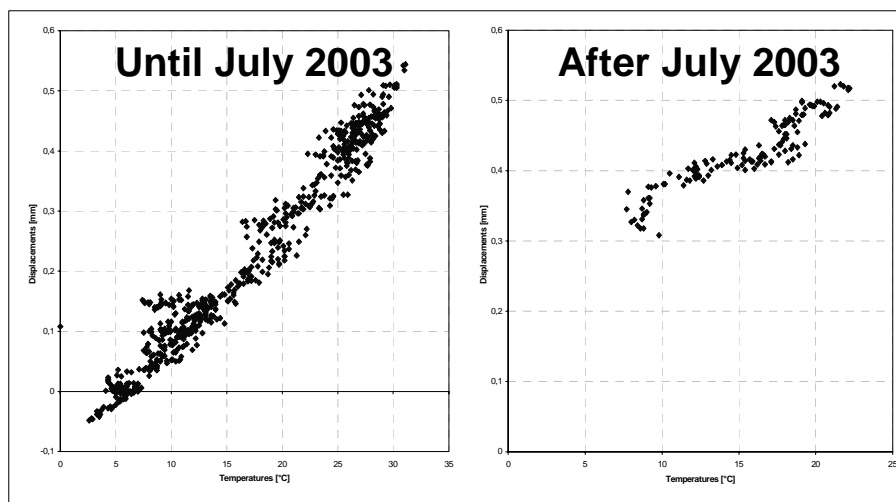
Sophisticated modeling and analysis of data was performed by University of Genoa. An example of results, the analysis of displacement – temperature correlation is presented in Figure 7 [3]. The regression coefficient between displacements and temperature changed in July 2003. High correlation coefficients between displacements and temperature were calculated in both cases. Therefore, it was concluded that the change in the regression coefficient indicated that some non-linear effect occurred.

Figure 7. Example of results obtained during Royal villa monitoring [3]

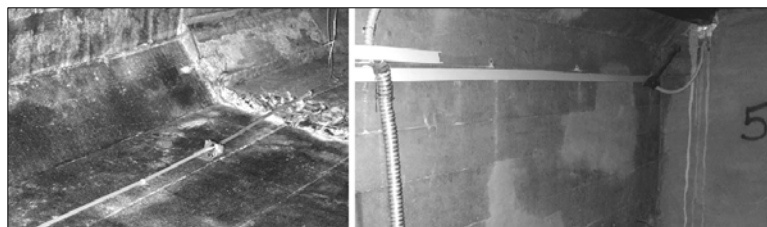
Figure 9. View to sensors installed in Bolshoi Moskvoretskiy Bridge (courtesy of Triada Holding)

The aim of monitoring is to increase the knowledge concerning the structural behavior of this very old structure, to increase safety and reduce maintenance costs. A total of 16 long-gauge sensors were installed in parallel topologies in order to continuously monitor the average strain along the arch, curvature in both the horizontal and vertical direction, and the deformed shape. In order to distinguish the thermal influence, six temperature sensors were also installed. The views to surface mounted sensors before and after the metallic protection is installed, are presented in Figure 9. The bridge is permanently monitored and the data is sent remotely to the control room using a telephone line. Results of the monitoring are not disclosed and therefore are not presented.

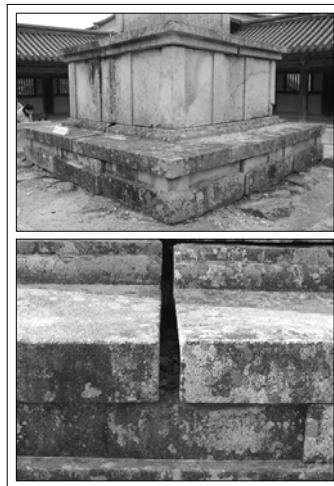
Figure 11. Openings created between the stones (courtesy of Golden Wheel)

Ageing of material, exposure to outdoor conditions, and differential settlements make the pagoda stones move. Since there is no mortar between the stones, the movement is relatively free and there is an elevated risk of pagoda distortion or serious damage. A view to Seok-Ga pagoda is shown in Figure 10, and the view to the openings created between the stones is highlighted in Figure 11.

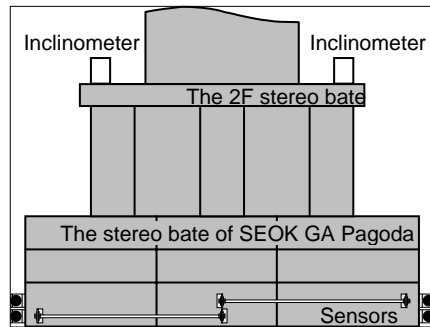
Figure 12. Sensors position

optimize maintenance and conservation works. Long gauge sensors were installed along the base while the inclinometers (tilt-meters) were installed on the second floor stereo bate. The sensor position is schematically presented in Figure 12 and a view of the sensors upon the installation in Figure 13. The sensors were surface mounted and protected with metallic plates. Inclinometers were also protected with for the purpose constructed boxes. Long-term continuous monitoring is performed. The results are not disclosed.

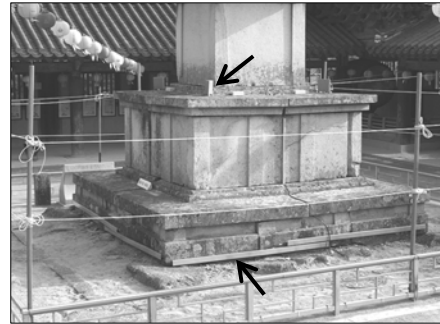
Figure 13. View to sensors and inclino-meters installed on Seok-Ga Pagoda (courtesy of Golden Wheel)
