RESPONSE EVALUATION OF PROTOTYPE NONCOMPOSITE I-BEAM BRIDGE UNDER STATIC LIVE LOAD TEST

Abstract

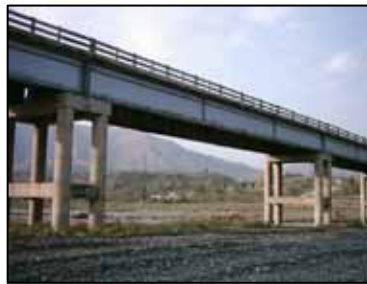
Figure 1: Ayub Bridge on Karakorum Highway (KKH – Silk Route), Pakistan

Ayub Bridge is located on the famous Karakorum Highway (KKH) at Havelian in district Abbottabad, Pakistan. The bridge was constructed in the late seventies by the National Highway Authority (NHA). It is comprised of six contiguous spans of 40meter each having non-composite steel plate girder with Reinforced Concrete (RC) deck slab, see Figure 1. The bridge is located on route, which is carrying major freight traffic between China and Pakistan. The bridge deck suffered severe damage in form of pot holes and had bad expansion joints, see Figure 2. The deck slab in each span had further five divisions, which resulted in six joints in each span. The NHA in its rehabilitation program intended to replace the old deck with a new composite deck slab. NHA asked to conduct a test to record the behavior of the bridge in its original configuration being in distressed state and latter wanted to compare these results with those of another test ,which would be done after rehabilitation works.

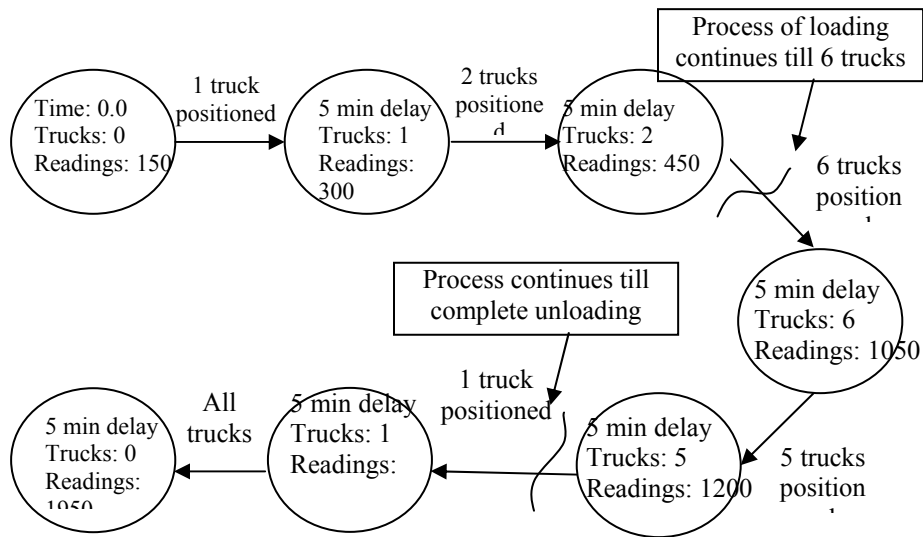
Figure 6: Incremental loading and unloading cycle for six trucks

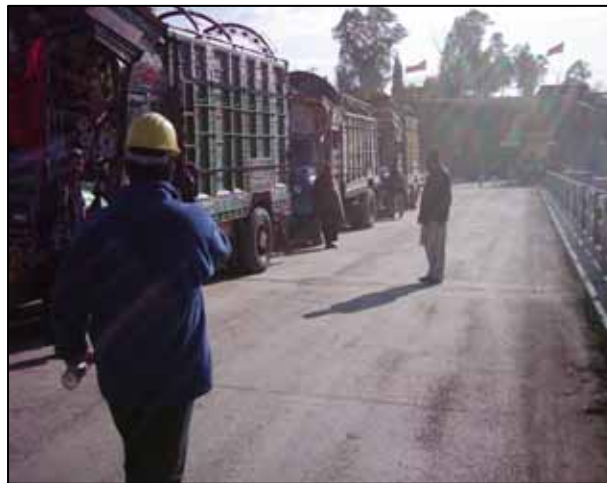
Figure 7: Three trucks loaded on the bridge

After completion of all markings, instrumentation and final checking of the instruments installed; the bridge was closed for all sorts of traffic including pedestrians. A pause of five minutes was given for achieving the steady state of bridge and the data logger unit was initialized and the first truck was brought to position 1 as shown in Figure 3. After precise positioning of the truck at position 1 all the staff evacuated the bridge deck. After waiting for five minutes, first set of readings for deflections and strains were recorded. Then a second truck was brought and position 2 was organized as shown in Figure 3; after waiting for five minutes a second set of readings was recorded. The cycle went on till all the six trucks were loaded as per position 6 of Figure 3; same process can be seen in Figure 6. Unloading started in the same fashion but now in reverse order till fully unloaded. The final sets of reading was taken for no trucks on the bridge deck after five minutes of pause when the last truck left the bridge. It is important to note that the distance between the two trucks (i.e. distance between rear axle of leading truck to the front axle of trailing truck) was kept 4,420mm, for reasons of simplification of placement of trucks on the bridge deck. See Figure 7 showing the three trucks loaded on to the bridge.

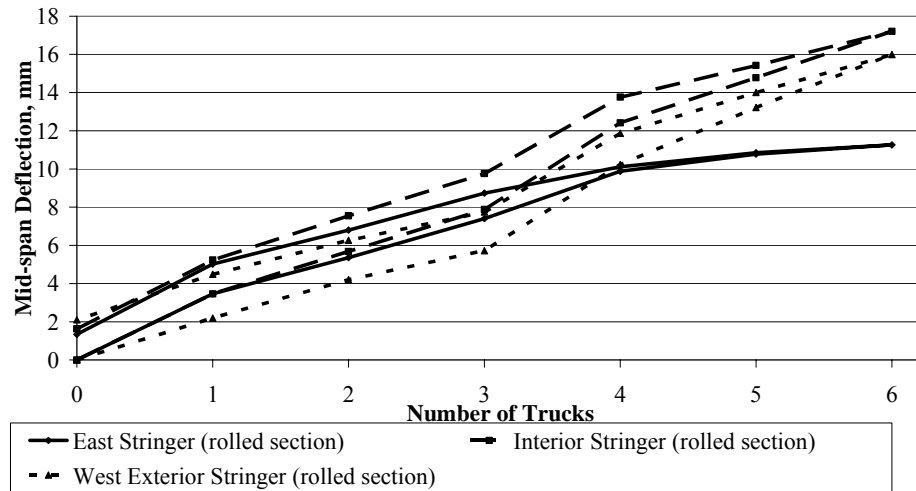
Figure 9: Midspan deflection of stringers for loading and unloading cycles

In Figure 9 deflection curve for the three stringers is plotted. Maximum deflection of 17.204mm is observed for the Interior stringer, whereas the deflection of 11.263mm is observed for the East stinger and deflection of West stringer is recorded as 15.997mm, for the six loaded trucks. Average permanent set of 1.689mm is considered to be contributed by the platform settlement.

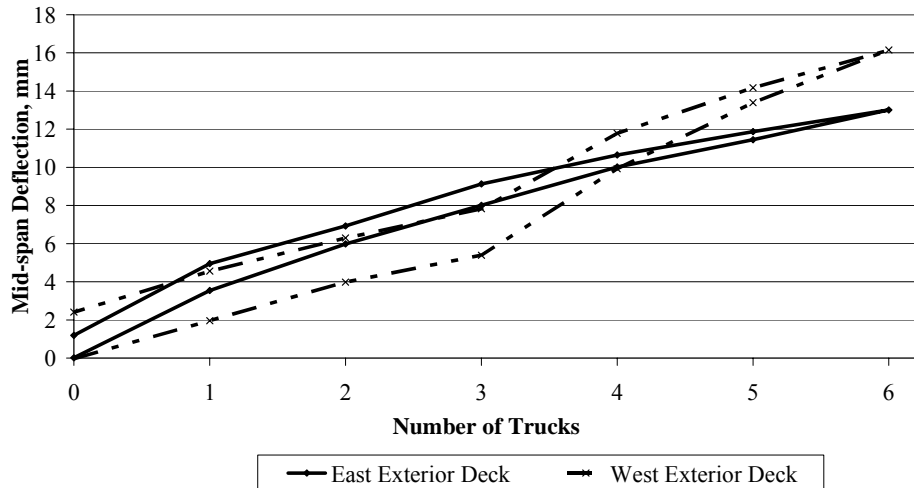
Figure 10: Midspan deflection of exterior concrete deck slab panels for loading and unloading cycles

Refer to Figure 10 for midspan deflection of exterior concrete panels. West exterior concrete deck panel deflects 16.149mm, whereas East exterior deck panel deflects a maximum of 13.007mm. Average 1.802mm deflection is potentially contributed by the platform settlement. However, 87.6% elastic recovery is still observed.

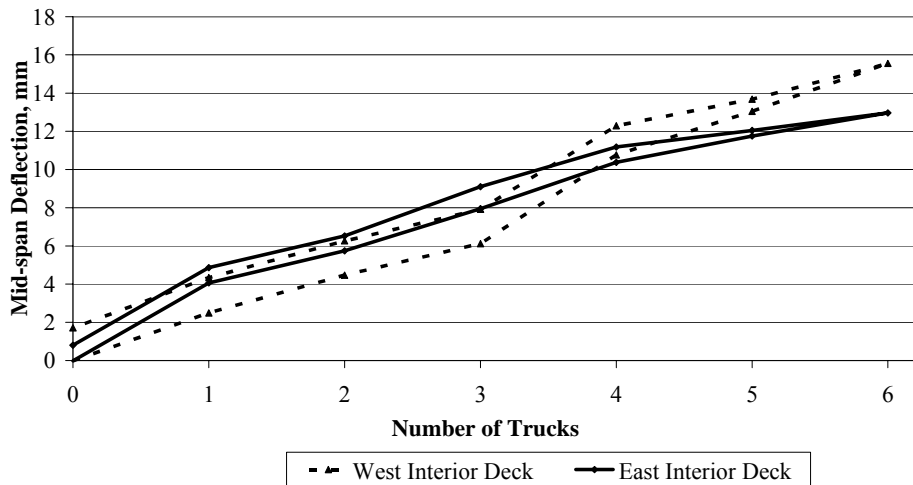
Figure 11: Deflection of interior concrete deck slab panels

Refer to Figure 11 for deflections of the two interior RC deck panels. The maximum deflection of 15.552mm is observed for the West interior deck panel and 12.966mm deflection for East Interior deck panel. An average 1.256mm of permanent set probably due to platform settlement is observed.

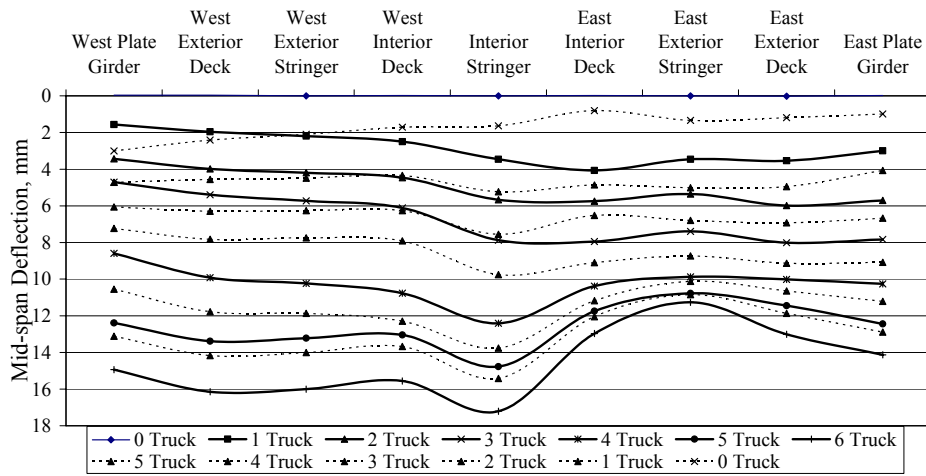
Figure 12: Midspan deflection profile of cross Section for loading and unloading

Refer to Figure 12 for deflection profile of cross-section incrementally loaded and unloaded. Absolute maximum deflection of 17.204mm occurs at the midspan of interior stringer. From the figure, it can be observed that West plate girder deflects more than East plate girder, similarly West exterior deck panel and West exterior stringer experience more deflection than corresponding counterparts on the Eastern parts of the bridge, despite the fact that loading of the six trucks is concentrated on the Eastern side of the bridge, as shown in Figure 3. Since trucks are positioned near the East plate girder, more deflection is expected in the Eastern components rather than the Western components of the bridge. An explanation behind this peculiar behavior can be attributed to the loss of contact between concrete deck panel and girders which reduce the longitudinal stiffness on the Western side of the bridge, thereby showing more deflection as compared to Eastern side of the bridge. Damaged bridge deck on the West side can be seen in Figure 2.

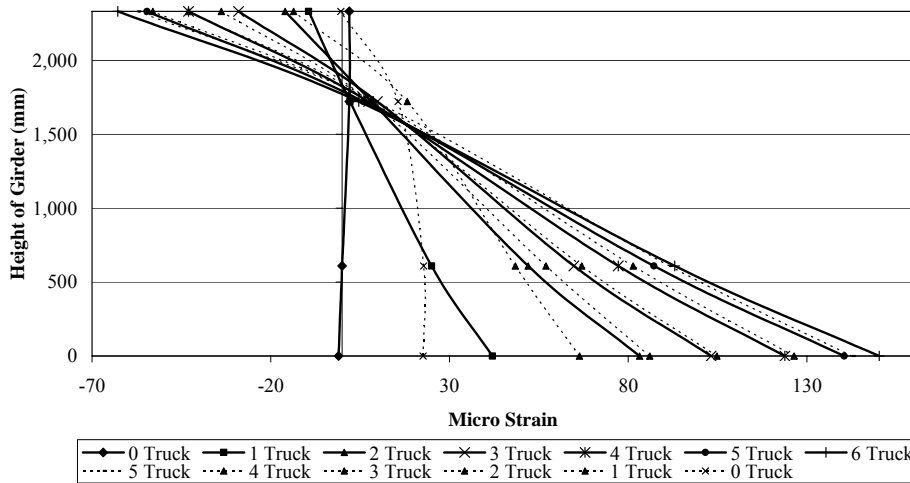
Figure 13: Strain profile of east main plate girder under incremental loading and unloading of six trucks

Figure 13 shows the strain profile of the East plate girder under loading and unloading. Maximum bottom flange strain of $+150.2\mu\epsilon$ (micro strain) is recorded, whereas $-62.8\mu\epsilon$ is recorded in the top compression flange (+ sign is tensile strain & - sign is compression). Main plate girders tend to exhibit some restraint, offered at the top flange due to friction between deck and surface of the flange. The amount of strain recorded for six trucks shows that strain range is considerably well within the linear elastic range. Due to limitation of space in this paper, only one case of strain profile is presented here.
