HEALTH MONITORING OF FIBER-REINFORCED CONCRETE OVERLAYS AT THE CHEMBIOE BUILDING, VANCOUVER, CANADA

Abstract

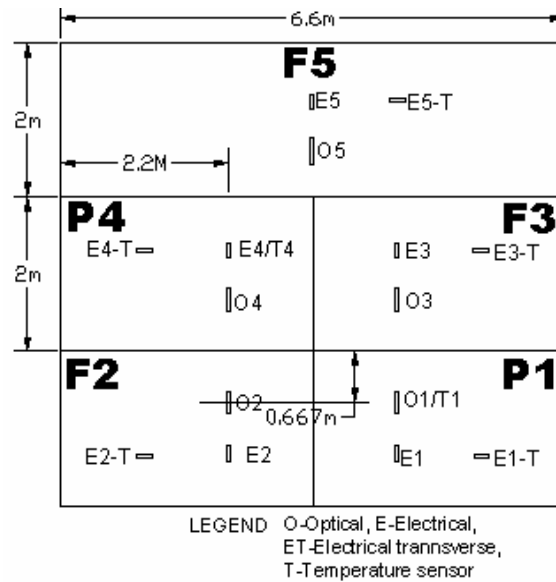
Figure 1. Five Sections of the Loading Dock (P1: Control; P4: HVFA; F2: FRC (7.5 lbs/ yd³); F3: FRC (5 lbs/ yd³); and F5: Joint-Free FRC Floor (7.5 lbs/ yd³))

2). Fibers are known to reduce the settlement of aggregates, and decrease bleeding. This, in turn, is expected to reduce the formation of bleed channels and decrease the ease with which flow can occur through the material. Secondly, fibers engage water in the mix and reduce the overall early age shrinkage. This is expected to produce a more 'in-tact' material with less internal cracking. Clearly, the ability of a given fiber to control plastic shrinkage cracking will depend among other things on the mix design, fiber type and dimensions, hydrophilic/hydrophobic nature of the fiber, concrete conditioning, placement details and the severity of the environment. This paper describes a field demonstration project where the role of fiber reinforcement was assessed when used in slabs-on-grade. The slabs were casted at the new ChemBioE (Chemical and Biological Engineering) building located at 2360 East Mall at the University of British Columbia, Vancouver. A 6.6 m x 6 m concrete slab was casted for the loading dock located near the south entrance of the building. The slab is located in the loading bay of the building and is expected to experience large loads during its service life. The slab was subdivided into five sections: four of size 3.3 m x 2 m each, and the fifth one of size 6.6 m x 2 m. (Figure 1). Two of the five sections (P1 and P4) had plain concrete with no fibers. P1 was controlled with no fly ash and P2 was one with a high volume (40%) of fly ash. F2, F3 and F5 were reinforced with a polymeric fiber (Hybrid Fiber Novomesh 950[®] produced by Propex, Inc., Figure 2). F2 and F3 had 7.5 lbs/yd³ and 5 lbs/yd³ of the fibers, respectively (see Table 1). Section F5 was designed to study the effect of not having any construction joints in a slab for more than 6 m. Section F5 had 7.5 lbs/yd³ of the fiber (same as F2). All placements were 150 mm (6") thick and had no steel reinforcement. In each section, two electrical strain sensors (one along the long and short direction) and one optical strain sensor in the short direction were placed (Figure 1).

Strain gauges were mounted on specially designed chairs (Figure 4), 25 mm below the top finished surface and equidistant from the slab edges (Figure 1). Every section contained two electrical (long and short direction) and one optical strain sensor along the short direction. Two temperature sensors were also installed alongside sensors ‘O1’ and ‘E4’ in placements P1 and P4 respectively, to monitor temperature changes. This allowed for any temperature correction to the strains.

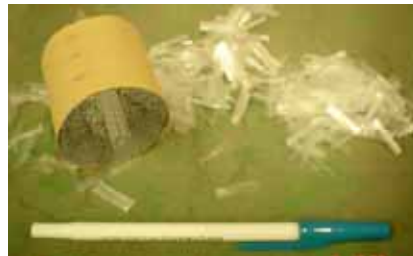
Figure 2. Novomesh 950[®] (Produced by Propex, Inc.)

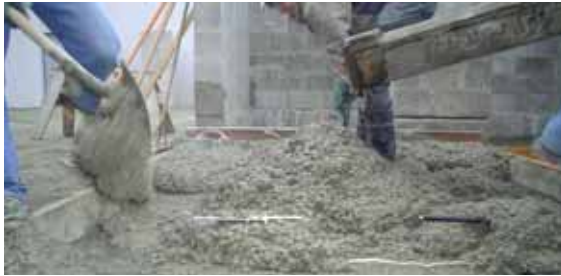
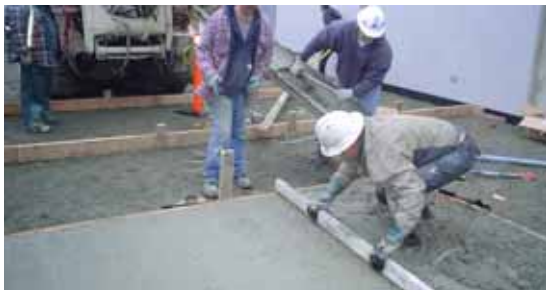
Figure 3. (a) Concrete Placement and (b) Finishing [Notice the sensors in (a)]

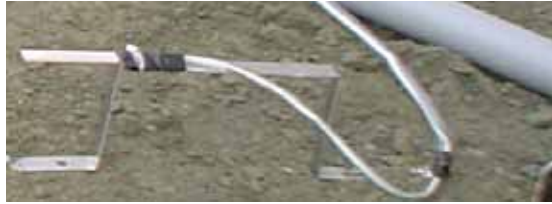
Figure 4. b) A Sensor Before Placing Concrete

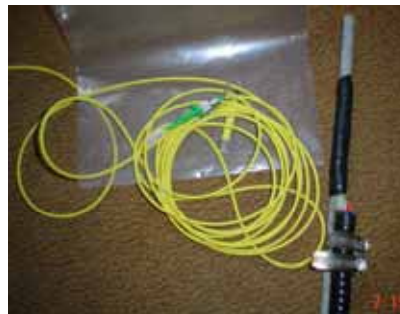
Figure 5. An FBG Optical Sensor

For the optical sensors, a Fiber Bragg Grating (FBG) was installed at mid-length of a 250 mm long GFRP rebar (Figure 5). The modulus of elasticity of the GFRP rebar was 42 GPa and that of the electrical sensor as reported by the manufacturer was 2.75 GPa. A single mode fiber optic patch cable was used with the fiber optic sensors and a FC/APC (angle polished connector) was used at the ends to extend the length of the cable. For additional protection, the embedded portion of optical cables and electrical wires were covered in a vinyl tubing.

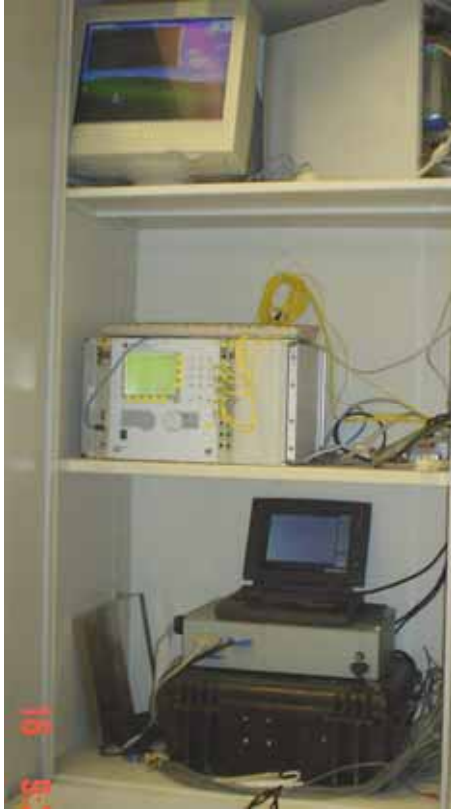
(a) Optical Sensor Readout Device

(b) Data Logger for Electrical Strain Gauges including WebDaq

Figure 6. On-Site Data Acquisition Systems

The entire data acquisition system (Figure 6) was installed on-site. For the fiber-optic sensors (FBGs) a data acquisition system manufactured by Iders, Inc. was used. The advantage of the system is that it monitors all FBG channels on a common time base, which simplifies post-acquisition processing of the data. The unit used in this study had a total of 8 channels. A custom software was used to acquire data onto a PC. For the electrical sensors, an acquisition system designed and built at UBC was used. The 13 channels system is configured to enable data monitoring via the Internet using a Web-based data acquisition called “WebDaq”.

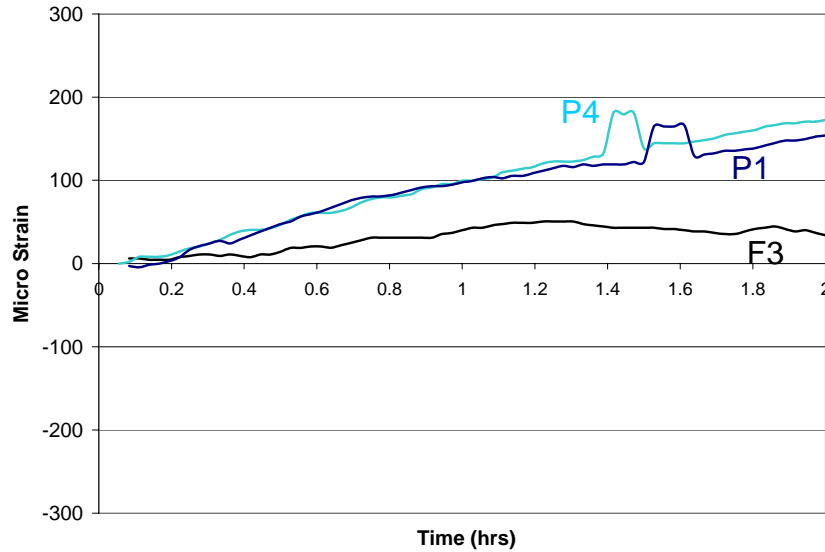
Figure 7 shows the presetting strains recorded with the electrical sensors. Notice that these sensors recorded a tensile strain during the first few hours after casting. This is expected as the temperature of concrete will increase due to the generation of the heat of hydration.

Figure 7. Averaged Pre-Setting Signals from Electrical Sensors (Tensile +ve, Compression -ve).

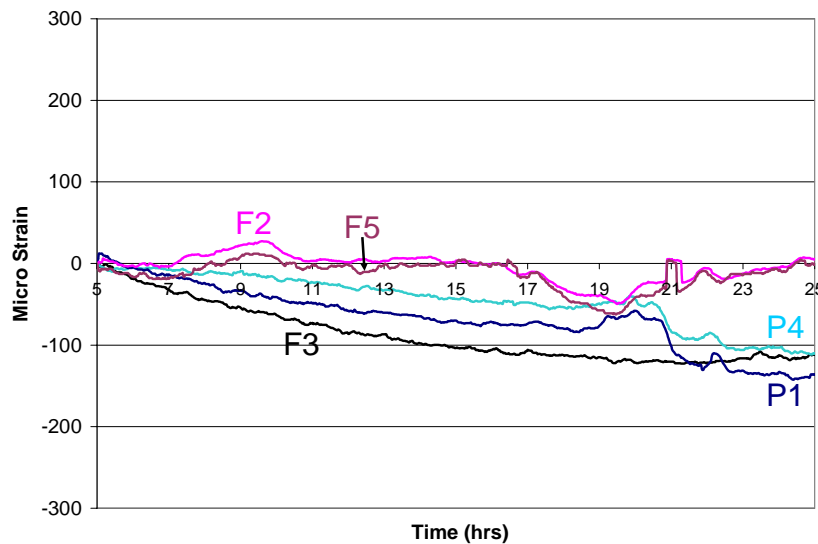
Figure 8 shows the average post-setting signals from the electrical sensors. Notice that the sensors in F2 and F5 (fiber reinforced concrete with a higher fiber dosage rate) recorded low values of strains implying a reduced potential for cracking. P1, P4 and F3, on the other hand, recorded greater strains than those in F2 and F5 placements, and these strain were compressive in nature. As will be noted later, unfortunately, the compressive strength of concrete in placement F3 was abnormally low, which may explain the high strains noted in this placement. The strain results of placement F3 may also indicate that a fiber dosage of 5 lb/yd³ is not sufficient to bring about a notable reduction in the measured strain.

Figure 8. Averaged Post-Setting Signals from Electrical Sensors.

The similar magnitude of strains in P1 and P4 is somewhat surprising as one would expect the placement with high fly-ash content (P4), to record somewhat higher strains due to reduced bleeding and greater potential for subsequent water loss. The reduced nature of strains in F2 and F5 is encouraging as it implies that a joint-free placement (F5) does not necessarily increase the risk of cracking. Post-setting strain increment data is given in Table 2.
