Experimental Investigation of the Mechanical Properties of Historic Stone Masonry Walls

ABSTRACT

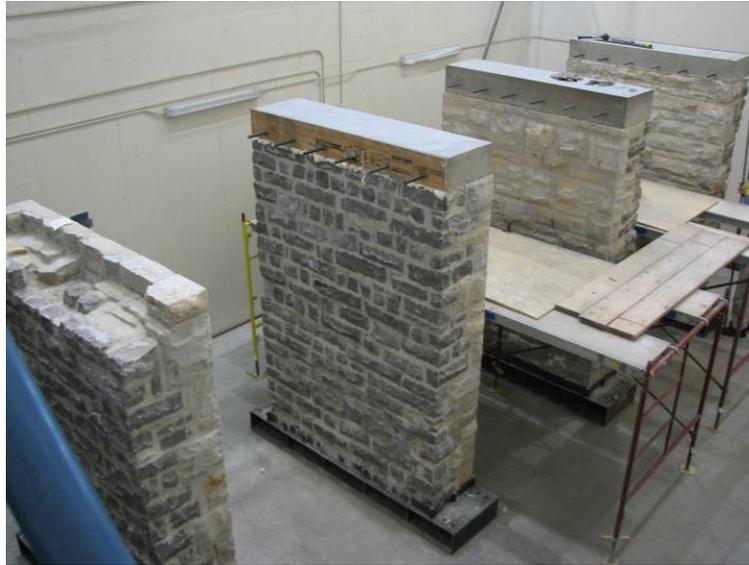
Figure 1 The walls after casting the concrete cap. Sandstone faces are visible in the two walls to the right of the figure, and limestone faces on the two walls to the left.

Eight stone-masonry double-wythe walls were built, where one wythe was of sandstone in a sneck pattern, while the other was of limestone roughly in running bond, Figure 1. The space between the two wythes was filled with lime mortar and rubble masonry, as can be seen in the right hand picture of Figure 2.. The mortar was chosen to replicate the mortar used for heritage structures of this type built around the middle of the nineteenth century and was composed of sand: lime: water in proportions of about 3: 1: 1. The walls are about 2.75 m high, 2.0 m wide and 0.54 m thick.

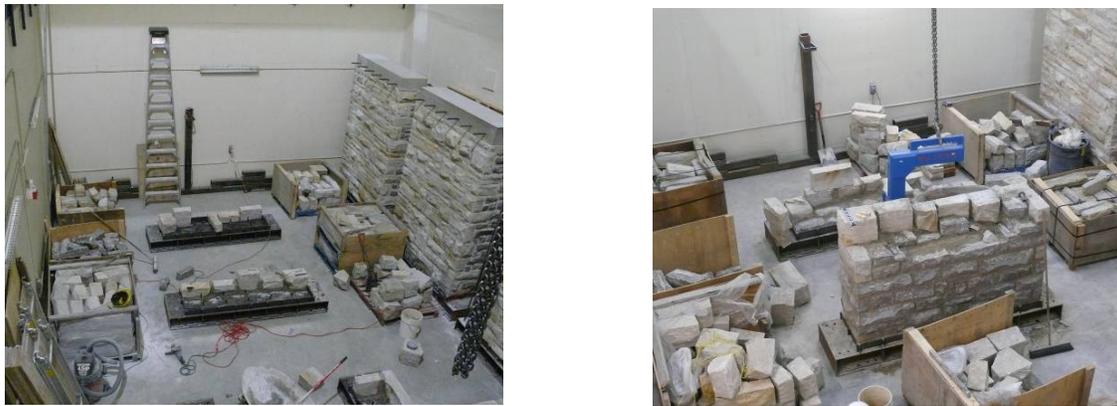
Figure 2 The walls in different stages during of construction.

The walls were built by skilled masons who work in the repair of heritage masonry structures. This was to ensure that the walls were truly representative of this type of historic structure. Construction of the walls is shown in Figure 2. The walls were built on specially designed steel base beams to allow for subsequent transportation. Each wall was built on a separate base beam (Figure 2) After the walls were built, a concrete cap was cast on the top of each wall, making the total height of the wall and cap, 3 m. The purposes of the concrete cap, other than to adjust the height of the wall, were to permit the placement of a top steel beam for transportation (Figure 3), and to allow fixation of the attachments required to connect the wall to the actuator in preparation for testing.

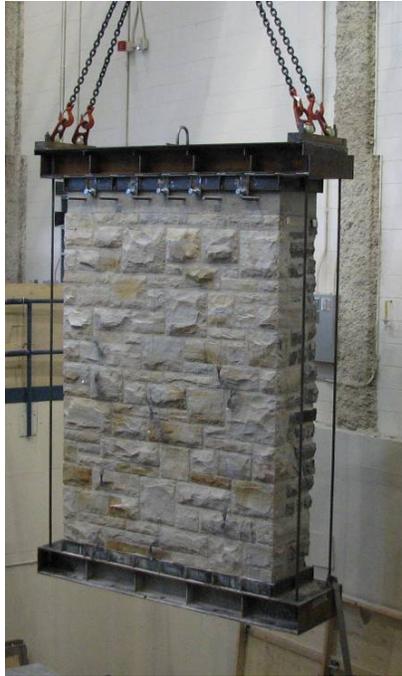
Figure 3 The lifting system designed for the walls. The base beam and the top beam are connected with four Dywidag bars visible connecting the outer corners of the beams, the system slightly stressed and the wall lifted.

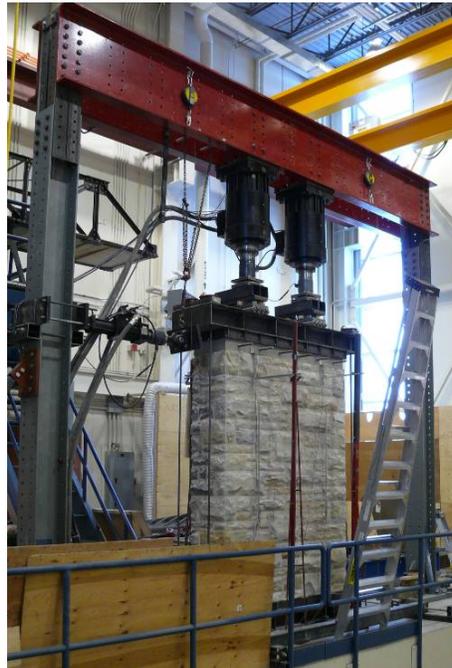
Figure 4 Schematic of the testing rig above, showing the two actuators at the top and one actuator to the side for lateral loading. A wall is shown in the rig in the picture below.

A testing rig was designed and assembled for the in-plane testing of the walls, shown in Figure 4. Two actuators, each of 1.5 MN capacity, are fixed to the top of the test frame to produce compression on the walls, while one 150 kN capacity actuator is fixed laterally to produce the lateral loads on the walls. The in-plane testing is designed to evaluate different properties of the walls: Young’s modulus, shear modulus, damping ratio, and energy dissipation. To determine these properties a series of tests is carried out on each wall.

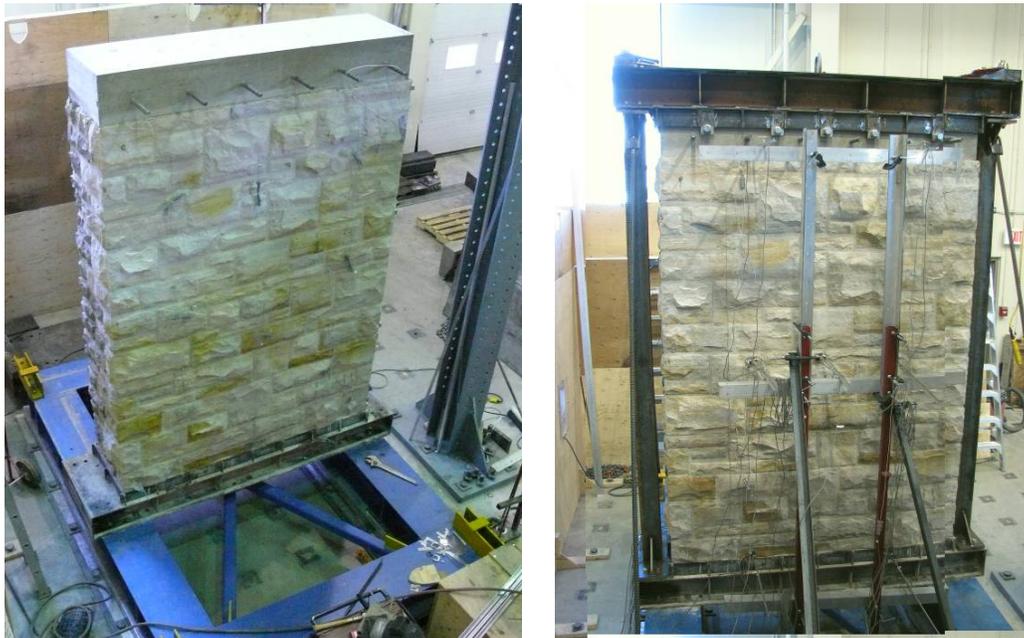
Figure 6 A wall placed on the shake table (left) and the frame designed to restrain its movement and its instrumentation on the shake table (right).

After the in-plane testing above, the walls are moved to a one degree of freedom shake table. The setup for the shake table is designed such that the wall is restrained at the top and bottom, simulating a wall between two floors in a building. The steel base beam on which the wall is built is bolted to the shake table. A frame is designed to tie the top of the wall to the corners of the shake table using 4 Dywidag bars to restrain the top, as shown in Figure 6. On the shake table, the walls are subjected to an earthquake simulation which is typical of eastern Canada. Such an earthquake is characterised by low amplitude and high frequency. The walls are
