## **PRELIMINARY STRUCTURAL ASSESSMENT OF KARIYE MONUMENT - NORTHERN ANNEX**

### **ABSTRACT**

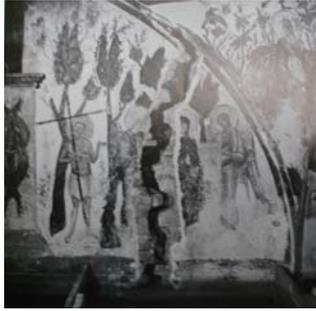
Figure 4 [8]

The terrain of Kariye monument has been shifting downhill. This phenomena caused cracks in the Eastern part of the building. A 8 cm wide crack, which occurred in the eastern bay of parecclesion, was repaired using cement mortar during 1950s (Figure: 4). The shifting of the terrain was also the reason for the construction of a flying buttress in the 14<sup>th</sup> century to support the eastern wall of the apse and later the collapse of buttress's central flyer, which was restored in 1950s (Figure: 5).

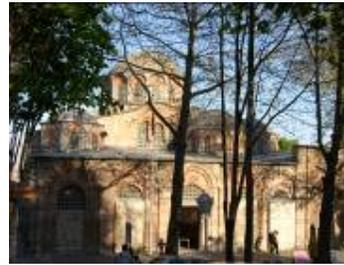
Figure 6

During the Ottoman restoration of the monument in 1875-76 to level the roof, a considerable amount of rubble was placed. This intervention not only changed the appearance of the monument, but also brought extra load to the structure. The appearances of the monument before 1875-76 restoration and today are presented in Figure: 6. The architectural additions made to the 12<sup>th</sup> century naos and bema had to be adapted to the older elements and meet certain functional requirements of the period, resulting in a structural irregularity, which is pointed out to be the major factor of the monument's structural weakness [3], [8]. According to Ousterhout, lack of vertical coordination of windows in the eastern wall of the north annex is the reason of the wall crack there [8]. The vertical non-alignment could be observed also in the western wall of the north annex, where the vent window is not aligned with the entrance door (Figure: 7).
