**Ninth Canadian Conference on  
Earthquake Engineering  
Ottawa, Ontario, Canada  
26-29 June 2007**

## **Seismic Safety of a Historical Row House Complex Built during Ottoman Period**

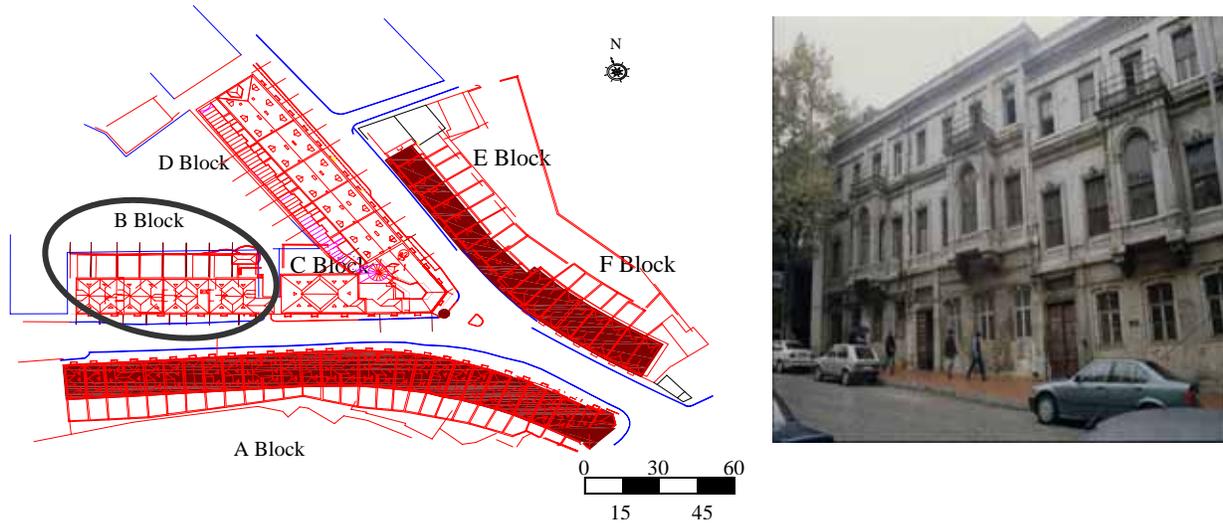
Figure 1. a) The site general layout plan of Akaretler Row Houses, b) The façade of the Block B.

Akaretler Row Houses, constructed around 1875 under the western influence, are the first example of row houses in the Ottoman Empire. These group houses, built by the financial support of the Ottoman Court, have a significant place among the other historical row houses, with their neo-classical façade, ornaments and location. These row houses erected in Istanbul consist of six blocks with 133 housing units, which were stepped parallel to the slope of the terrain. The region on which the row houses are located had been exposed to numerous destructive earthquakes during the history, (Ilki et al 2006). According to Seismic Zoning Map of Turkey, these houses are located on the second degree seismic zone, representing quite high seismic risk. The general layout plan of these blocks, namely A, B, C, D, E, and F can be seen in Fig. 1. The façade of Block B is presented in Fig.1. The original structural system of Block B consisted of masonry walls and vaulted brick floors. However, the brick floors were demolished and reinforced concrete plate slabs were constructed during the past restoration activities. The main construction materials of Block B are stone for foundations, and brick for the walls of the basement and upper structure. While the doors and balustrades of balconies of these masonry houses were made of cast iron, stairs were originally built with masonry or wood, which were later reconstructed using reinforced concrete. Bricks were also used for relatively smaller span arches covering the entrance of corridors. The cut stones on façade are for a decorative finishing rather than being a part of the structural system. The Block B has eight houses attached to each other. Each of them is three stories high consisting of entrance story and two upper stories, Fig. 2. The levels of some stories are different from each other due to the slope of terrain as shown in Fig. 2. The floors have different heights, varying between about 3.15 and 5.0 m. The plan of the building is given in Fig. 3. The structure has a rectangular plan that is about 17 m wide and 77 m long. Several additions were made including new brick masonry walls (the blue color in the plan), and reinforced concrete columns (brown color in the plan), during past

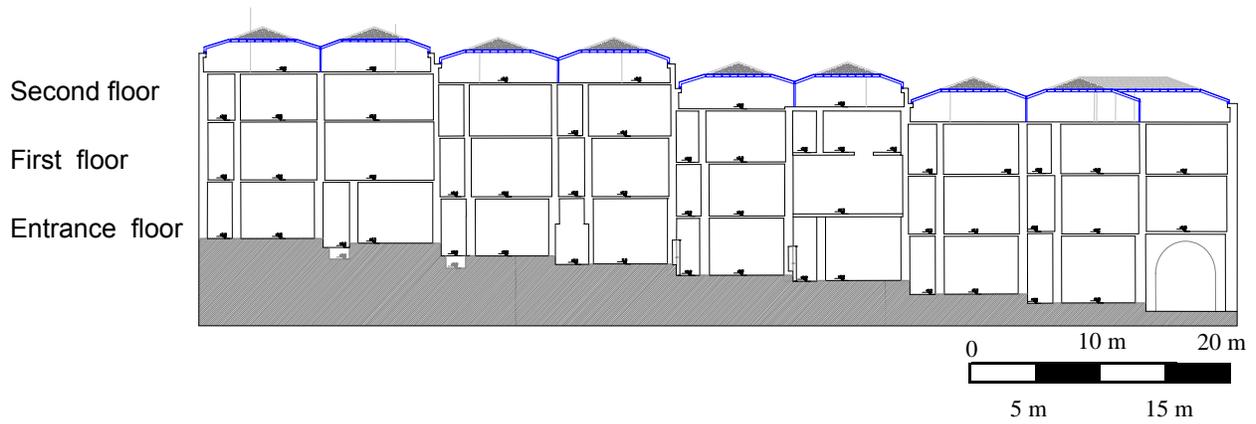
Figure 2. The longitudinal section of the B Block.

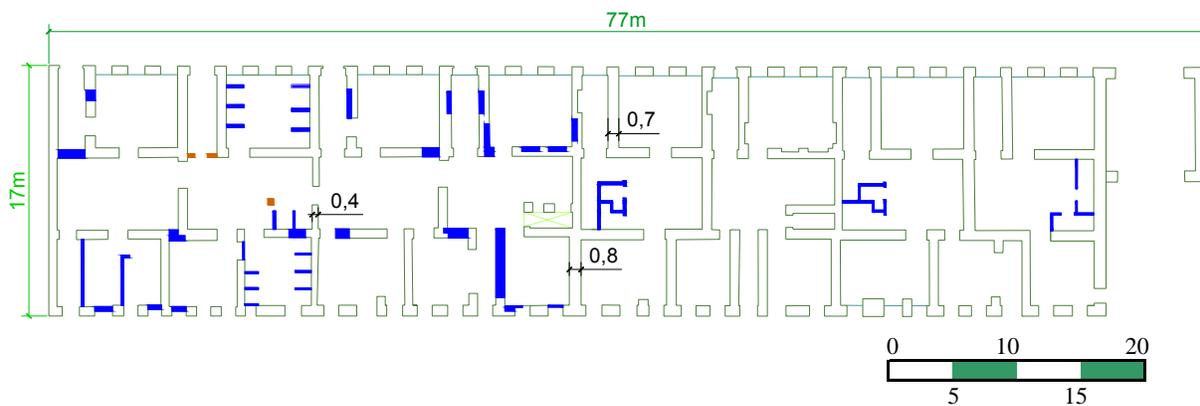
Figure 3. The plan of the B Block (entrance level).

restoration works. The thicknesses of walls are varied between 50 and 120 cm for outer walls and between 20 and 70 cm for inner walls.

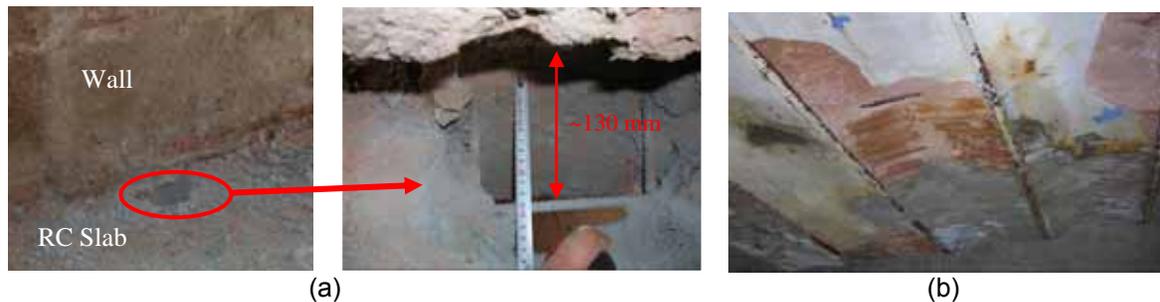
Figure 4. a) The connection of existing walls and reinforced concrete slabs of Block B, b) original vaulted slabs in Block E.

The buildings have experienced a severe earthquake in 1894, which effected many different parts of Istanbul. According to available information and observations on-site, the Block B of Akaretler Row Houses did not experience a considerable seismic damage after 1894 Istanbul Earthquake. Although not formed because of seismic events, several minor cracks in structural walls are observed. According to the authors, these cracks were formed due to singular loads concentrated on walls, mostly because of inadequate lintel lengths and/or local minor alterations in structural plan. Since the damages are almost negligible, it is concluded that these damages are not needed to be taken into account while assessing the seismic safety of the buildings. It should be noted that, although not directly related with seismic safety, some of the newly constructed reinforced concrete flat slabs have some damages, mostly because of insufficient flexural capacity due to improper placement of reinforcing bars, careless formation of supports and low concrete strength. Although the reinforced concrete slabs are not perfectly connected with structural walls, according to the authors, the friction forces between the structural walls and the reinforced concrete plates would be sufficient for providing the diaphragm effect. No doubt, the replacement of vaulted brick floors with reinforced concrete flat slabs improves the diaphragm effect, since the original vaulted slabs, which are still present in Block E and F had been poorly constructed. The connection of existing walls and reinforced concrete slabs of Block B, and original vaulted slabs in Block E are shown in Fig. 4.

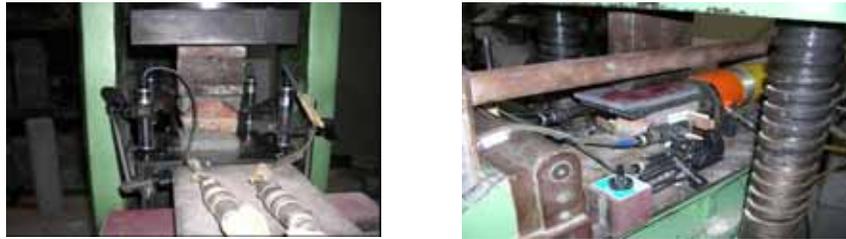
a) Compressive strength test                      b) shear strength test  
Figure 5. Laboratory tests.

taken from these walls. Core samples are used to determine the compressive and shear strength, and elastic modulus of the walls, Fig. 5. These samples consisted of two-brick parts and a mortar layer between them. These cylindrical specimens have a diameter of about 95 mm and a length of 100 mm.

The compressive strength tests are conducted on core samples taken from different floors of the structure, Fig. 5a. While evaluating the results of these tests, specimens exhibiting large variations were taken out of evaluation according to Chauvenet Criteria (Akman 1978). The compressive strengths and elasticity moduli are presented in Table 3. As seen in this table, both compressive strength and elasticity moduli of the specimens taken from the second floor are significantly lower than the specimens taken from the entrance and first floors. The buildings have not been maintained for almost more than 10 years. Therefore, this difference in compressive strength and elasticity modulus may be attributed to reduction of their capacities due to wetting and drying cycles, and humidity conditions, caused by insufficient maintenance of the roofing system. The relationships of axial stress and average axial strain are given in Fig. 6. Average compressive strength is 2.96 MPa and minimum compressive strength is 1.99 MPa. It should be noted that the allowable compressive stress for ordinary structural bricks produced in the field kilns is given as 0.8 MPa by the Turkish Seismic Design Code (2006).

Shear strength of core specimens is experimentally found for three different vertical stress levels, which are 0, 0.15 and 0.3 MPa, Fig. 5. These values are chosen to represent vertical stresses in different floors, namely no axial stress case represents the situation in the second floor, while the axial stress levels of 0.15 and 0.3 MPa is assumed to represent the first and entrance floors, respectively. The location of the specimens in the buildings, vertical stress, axial load and shear strength are shown in Table 4. The relationships of shear stress and average horizontal displacement are given in Fig. 7. Average shear strengths are calculated for each axial stress level and shown in Table 4. As seen in this table, shear strength of cores under varying axial stress conditions are around 0.35- 0.40 MPa. According to Turkish Seismic Code; the shear strength of walls constructed with ordinary solid bricks considered is given as 0.2 MPa, when experimental data is not available. Since the applied axial stresses on the bricks are not high, the shear strengths are found to be close to each other for different levels of axial stresses. It should be noted that many factors may also affect the shear strengths obtained, such as the quality of jointing mortar, environmental conditions, the processes during taking out the cores from walls and preparation process of cores for experiments. Therefore it is believed that the obtained shear strengths just give general information about material qualities.

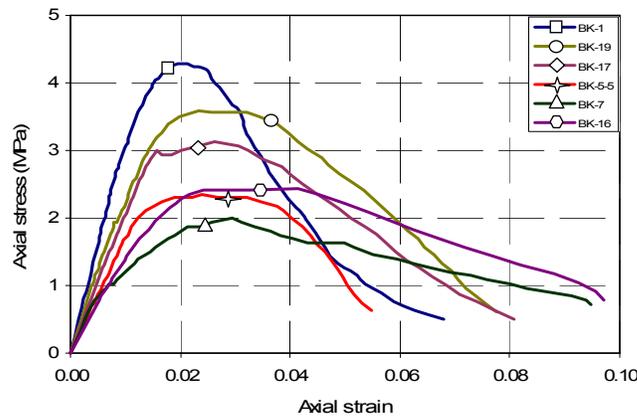
Figure 6: Axial stress-average axial strain relationships of the core samples.

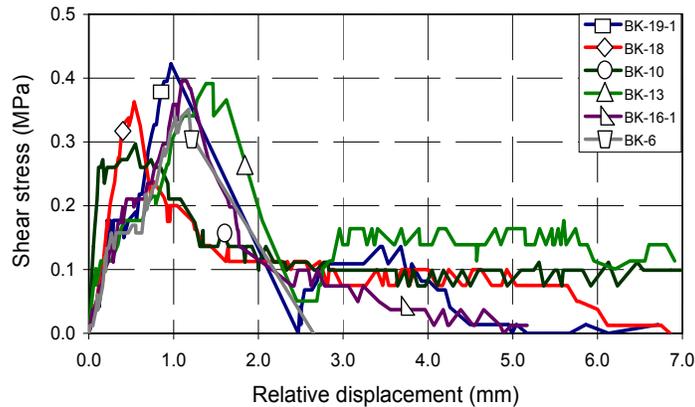
Figure 7. Shear strength-average horizontal relative displacement relationships of the core samples.

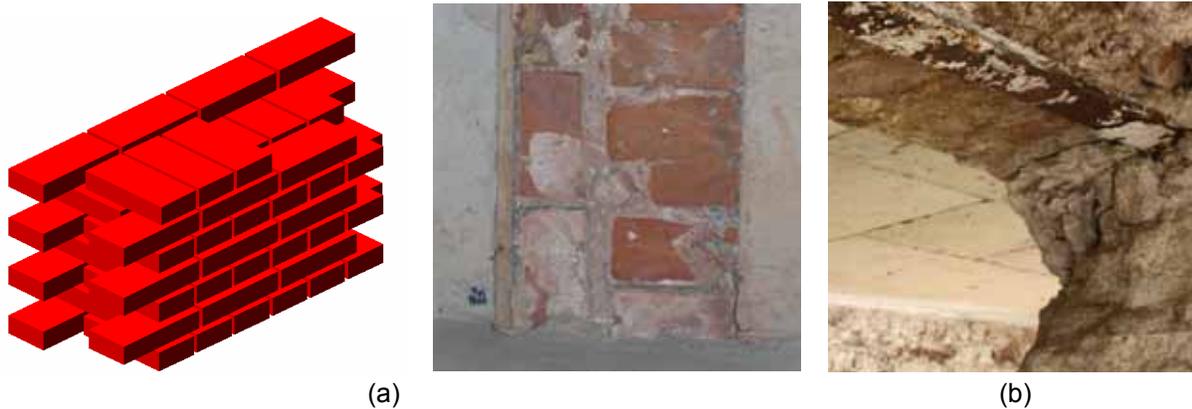
Figure 8. a) Brick arrangement of the masonry walls, b) the steel tie.

Composite structure of the walls is composed of bricks, mortar and steel ties, Fig. 8. Deteriorated by the environmental conditions and damaged by several interventions during the last century, steel ties, which were originally aimed to compensate the lack of diaphragms constraining the main walls, are evaluated to be out of service. Five different types of brick, having average dimensions of 60x110x240 mm<sup>3</sup> have been

used in the construction. Almost all masonry walls have cross bond (also known as English bond) brick arrangements with approximately 20 mm thick horizontal and 10 mm thick vertical mortar joints, Fig. 8.

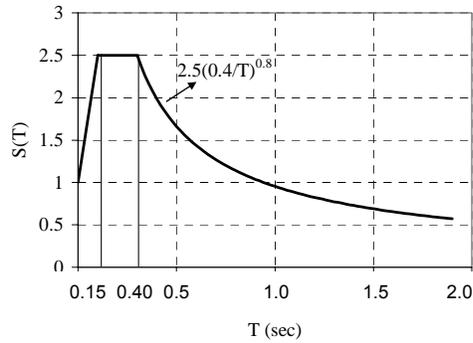
$$V_t = \frac{W \times A_0 \times I \times S(T)}{R_a(T)}$$

$V_t$ : Base shear force

$W$ : Total weight of the structure

$A_0$ : Effective ground acceleration coefficient (0.4g in this case)

$I$ : Building importance factor (1 in this case)

$S(T)$ : Spectrum coefficient (2.5 in this case)

$R_a(T)$ : Seismic load reduction factor (2 in this case)

Figure 9. Calculation of base shear force according to Turkish Seismic Design Code, 2006.

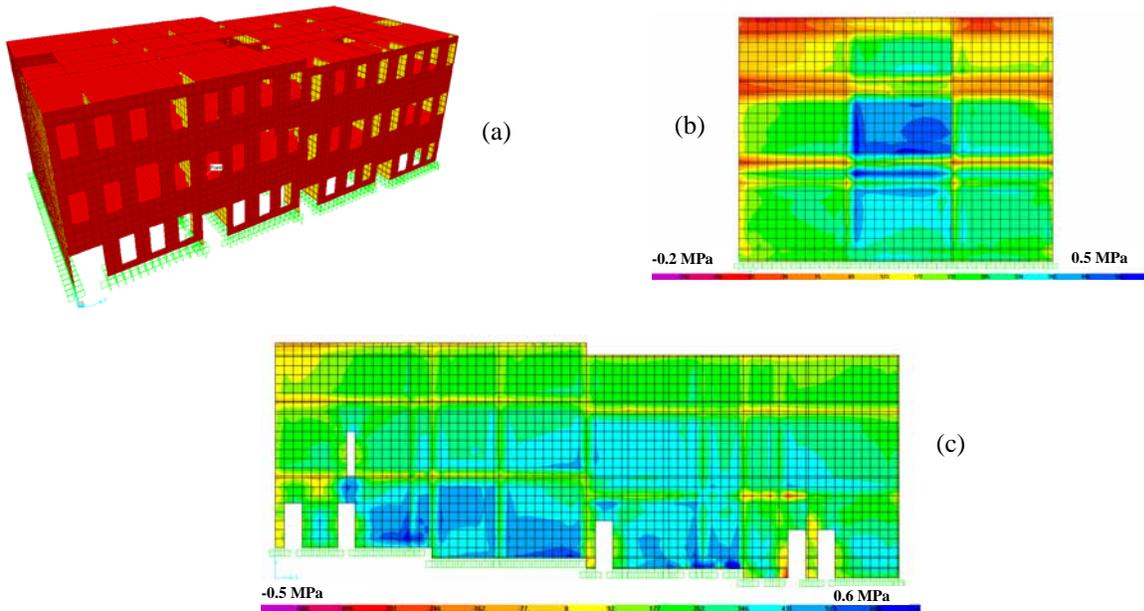
Figure 10. a) Three dimensional mechanical model b) Shear stress contours in transverse direction c) Shear stress contours in longitudinal direction.

In order to investigate the seismic safety of the building, a macro-level linear elastic finite element analysis has been carried out. Though having limitations, linear elastic analysis constitutes a useful tool for understanding the general seismic behavior of masonry structures. Walls and reinforced concrete slabs of the three dimensional analytical model has been constructed by using four node shell elements and SAP 2000 structural analysis program. Since the structure has a form of repeating blocks in plan, aiming to decrease the run time, only 4 of the repeating blocks out of 8 has been taken into consideration during the modeling phase. The analysis has been performed for vertical and horizontal loads. Vertical loads includes the dead weight of the structure (unit weights:  $18 \text{ kN/m}^3$  for masonry and  $25 \text{ kN/m}^3$  for reinforced concrete) and the live load acting on the slabs ( $2 \text{ kN/m}^2$  as defined in TS 498/T1 (Turkish Standards Institution, 1997)), while the horizontal loads are derived through Turkish Seismic Design Code (Ministry of Public Works and Settlement, 1998). The equivalent static earthquake forces are acted in both longitudinal and transverse directions of the building. The structure is located in European part of Istanbul on a highly seismic zone, which is defined as second degree seismic zone. However, considering the uniqueness of the structure and the demand of the owner, the design horizontal acceleration required for the calculation of the base shear force is taken as  $0.4g$  as given for the first degree seismic zones in the Turkish Seismic Design Code (Ministry of Public Works and Settlement, 1998), Fig 9. As also stated in the same code; building importance factor and spectrum coefficient are taken as 1 and 2.5, respectively. For masonry buildings, the seismic load reduction factor based on the ductility of the structural system is given as 2.5 by the Turkish Seismic Design Code 1998, while it was reduced to 2.0 in Turkish Seismic Design Code 2006. Therefore, although 1998 code is still valid, to be on the safer side, the seismic load reduction factor is taken into account as 2.0. Consequently, base shear coefficients are determined as 0.5 for longitudinal and transverse directions. Utilizing the average compressive strength value obtained from laboratory tests on brick masonry cores, the elasticity modulus is obtained approximately as 600 MPa (200 times the wall compressive strength) as formulated in the Turkish Seismic Design Code (Ministry of Public Works and Settlement, 2006). Natural vibration periods of first two modes are 0.28 and 0.27 seconds for longitudinal and transverse directions, respectively. A general view of the three dimensional mechanical model and shear stress contours of typical axes for longitudinal and transverse directions are shown in Fig. 10. In order to verify the results obtained from the three dimensional linear elastic analysis, a hand calculation has also been done. Average shear stresses obtained by dividing the earthquake induced shear forces by the net wall areas of each story results as 0.37, 0.30, 0.17 MPa for the entrance, first and second stories of the longitudinal direction; 0.24, 0.33, 0.20 MPa for the entrance, first and second floors of the transverse direction, respectively. These average shear stress values are in good agreement with the results of finite element analysis. Comparing the experimental shear strength values with these results it can be concluded that the structure has

sufficient capacity for a design earthquake foreseen in the Turkish Seismic Design Code (Ministry of Public Works and Settlement, 1998 and 2006). According to the results of the analysis, the average compressive stresses are around 0.5 MPa, which is below the 2.96 MPa compressive strength value obtained from laboratory tests.
