The 6th International Conference on
Structural Health Monitoring of Intelligent Infrastructure
Hong Kong | 9-11 December 2013

STRUCTURAL HEALTH MONITORING OF AN ALASKA BRIDGE

J. Leroy Hulsey ¹, Feng Xiao ¹ and Gang S. Chen ²

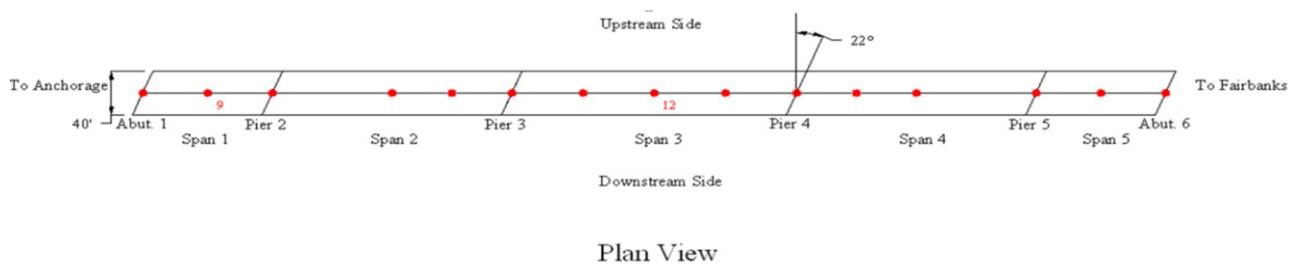
Figure 2. Portable Accelerometer Location and Number

A total of 15 portable accelerometers were used in the ambient tests as shown in Figures 2. The accelerometers were located at piers and mid-spans. Spans 2, 3 and 4 had more data collection points, because of their longer spans. Accelerometers were all put in one line in the center width of the deck. They were placed on the flat clean driving surface. Each test was repeated three times to ensure accuracy. Vertical, transverse and longitudinal accelerations were measured. The accelerometers used measured acceleration in only one axis. Because of this, each test of the three tests had to be repeated three times to capture acceleration in all three axes.

As part of the controlled ambient test, an A-30 AKDOT&PF boom truck was used to excite the bridge. Traffic control was used to stop pedestrian traffic in an effort to isolate the excitation caused by the test vehicle. The bridge was closed and non-windy during the dynamic test which reduced the influence of other erroneous input loads. The A-30 boom truck crossed the bridge from Fairbanks to Anchorage (traveling south) in the upstream lane with a speed of 45 mph. The bridge was kept closed until the vibration was totally damped out.

We investigated the dynamic behavior of the Chulitna River Bridge by using an ambient free-decay response. By using a frequency spectrum analyses, several components at 1.50, 2.20, 2.85, 3.23, 4.58 Hz were characterized. The measured frequencies of 2.85, 3.23, 4.58 Hz are bridge vertical modes and 1.50, 2.20 Hz are bridge longitudinal modes. The measured acceleration data for the ambient tests compared well with the analytical values that were calculated using a SAP200 three-dimensional finite element model (FEM).

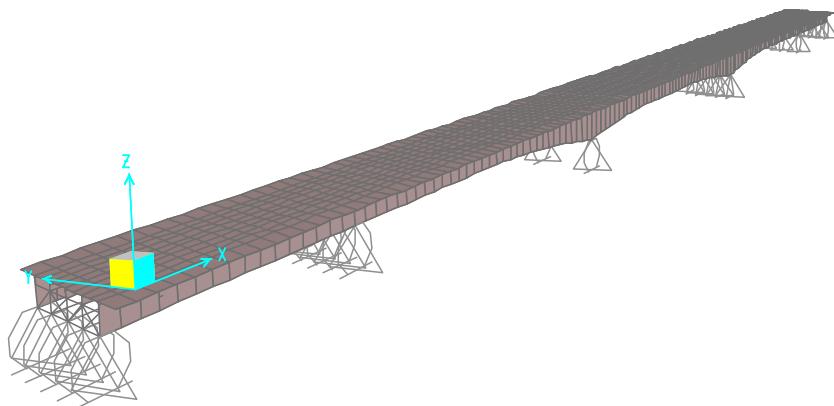
Figure 3. Chulitna River Bridge: 3-D FEM Model Looking NW

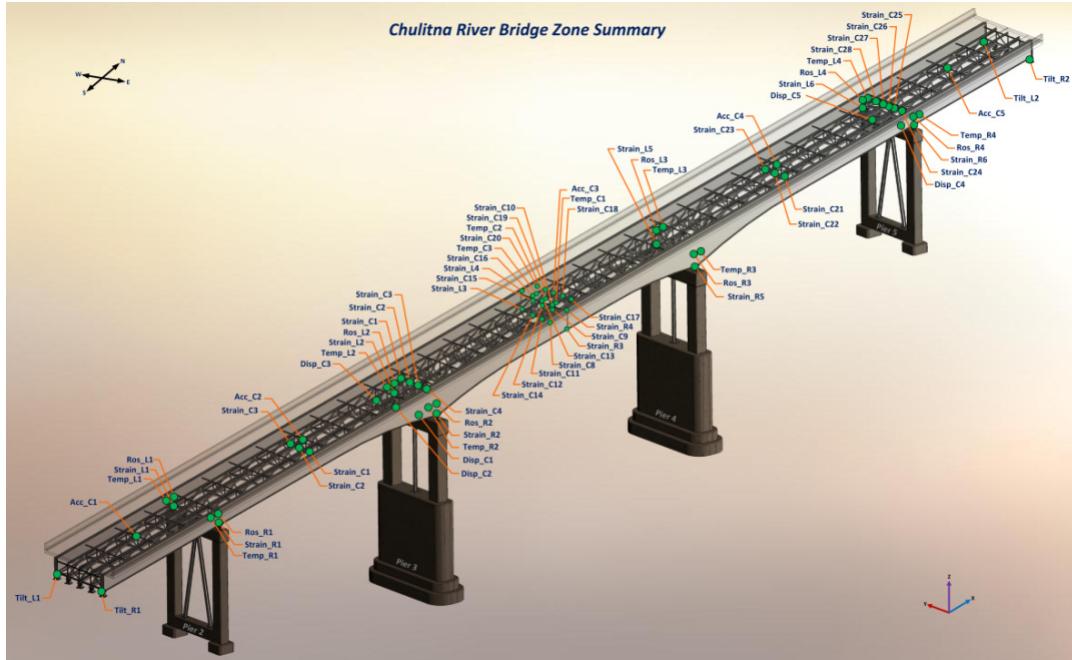
A total of 73 sensors were selected to be installed to monitor the behavior of this bridge. The sensor layout shows as Figure 4. The sensor arrangement was selected to best provide information about changes in the load distribution in girders and trusses. Most of the sensors are located in places that have the lower load rating factors and others are used to observe load distribution throughout bridge.

We attempted to measure the shear force effects by placing eight optic fiber Bragg grating (FBG) rosette strain sensors near the piers on the outside girders in that the disconnection of inside bearings will increase shear force on outside girder. We are attempting to measure flexural strain caused by moments near the mid-spans. These mid-span flexural strains are monitored by twelve optic FBG strain sensors placed near mid-spans of the girders. To monitor bending and axial forces in the trusses, fifteen optic FBG strain sensors are located within the composite trusses. The live load distribution in the girders and the trusses can be calculated by comparing the

force distribution between the girders and the trusses. For monitoring the load transfer through the cross frames and the concrete deck, twelve optic FBG sensors are placed on the cross frames' diagonal trusses and the concrete deck. Other optic FBG sensors are located on members that are considered to have the lower load ratings. Five optic accelerometers are used to monitor changing of stiffness's in the trusses and girders. The supports are monitored for rotation with optic tilt meters. If all supports are not free to rotate as they should the bridge may exhibit a twisting condition. This accounts for an additional four sensors. Five displacement optic sensors are used to monitor the displacement of the truss bearings.

Figure 4. Sensor layout

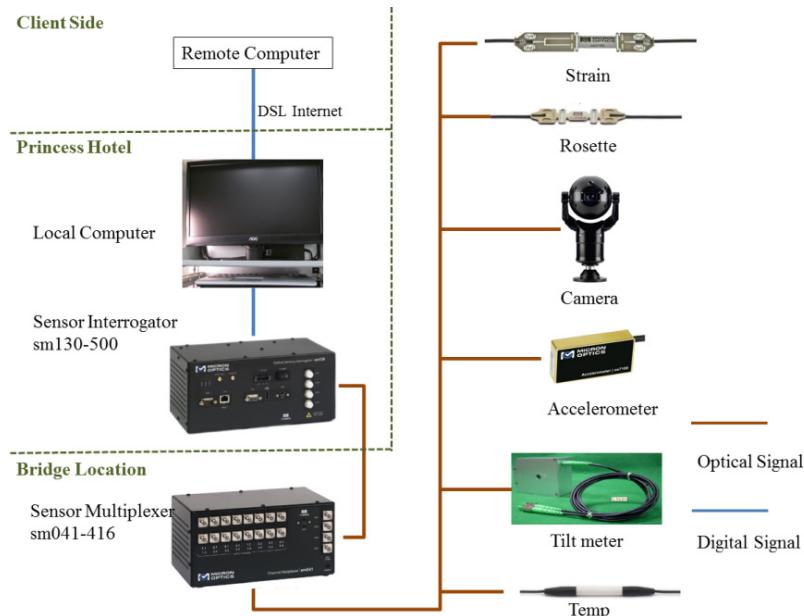
The structural health monitoring system is composed of five parts: sensors, sensor multiplexer, sensor interrogator, local computer and remote computer. The sensor Multiplexer is located in a control panel at the bridge. The panel has instruments that regulate both temperature and humidity within the enclosure. The sensor interrogator and local computer are located in control panel at the Mt. McKinley Princess Wilderness Lodge approximately 4 km (2.5 miles) away.

The sensor interrogator sends four optic signals (lasers) from the Utility room to the sensor multiplexer at the bridge via four fiber optic channels. The multiplexer is composed of four switches; these four switches distribute the incoming four channels to sixteen channels. Each of the sixteen channels is capable of supporting a sensor array of up to eight sensors. That laser signal, via the multiplexer, is sent to each sensor array. The laser signal is then reflected back to the interrogator by mirror-like imperfections in the fiber strand at each of the sensor locations. These imperfections, called fiber Bragg gratings (FBG), change in dimension when strained. This strain in the grating produces variations in the laser wavelengths that are reflected. Each sensor in an array contains a unique FBG that only reflects specific wavelengths exclusive to that sensor back to the interrogator. The interrogator then interprets these optic signal reflections and transforms the optic signal to a digital signal and sends it to the local computer. The local computer then calculates stores and exports the data to a remote computer via DSL internet (Figure 5). The fiber optic sensors are connected in series within arrays. Fusion splices are preferred over mechanical connectors to minimize signal loss (attenuation).

Figure 5. System configuration
