STRUCTURAL HEALTH MONITORING OF LINDQUIST BRIDGE

Abstract

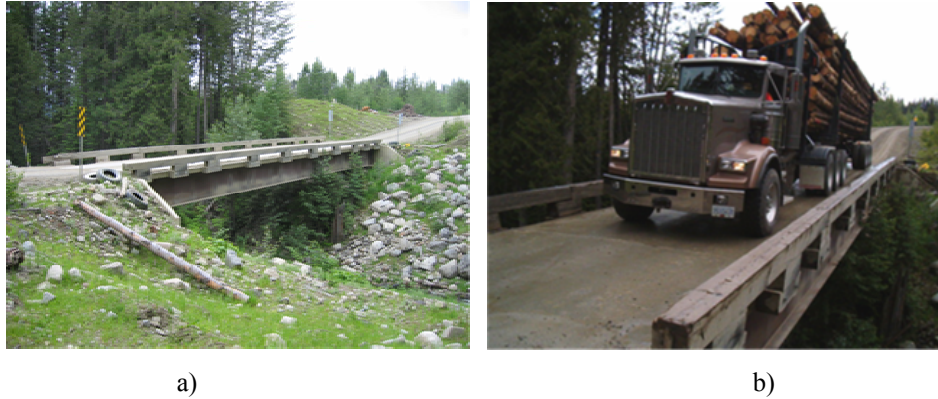
Figure 1. The Lindquist Bridge: (a) a view of the bridge; (b) a logging truck on the bridge.

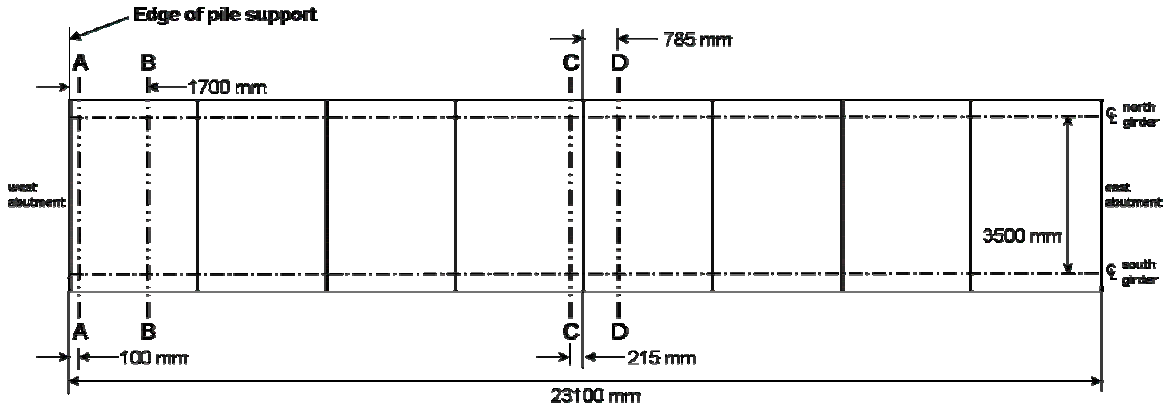
Figure 3. Locations of instrumented cross-sections.

The orientation of the Lindquist Bridge is roughly in the east-west direction. A plan of the bridge is shown in Figure 3 with sections AA to DD denoting the locations where electrical resistance strain gauges were installed. A summary of the sensor locations is found in Table 1.

In order to investigate this further in the 2006 monitoring, a strain gauge was installed on the bottom flange of the south girder at Section A-A (Figure 3), which is located only 100 mm from the edge of the pile support. In a truly simply supported bridge, the strains at this location would have been tensile and very small in magnitude. The bottom flange strains induced by the test vehicle moving at a crawling speed near the support are plotted in Figure 7a while a photograph of a girder support is shown in Figure 7b. It can be seen in Figure 7a that the strains at the bottom girder flange near the support are negative, i.e. compressive. The maximum magnitude of these compressive strains is about $34 \mu\epsilon$ and is not small compared to the maximum tensile girder strain at the mid-span which is about $200 \mu\epsilon$ (Figure 6). Thus, it is confirmed that the girders of the Lindquist Bridge are not simply supported, and have substantial bearing restraint.

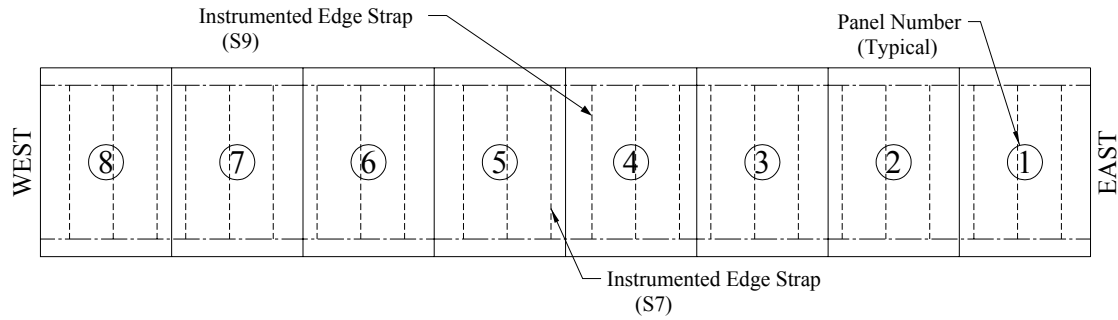
Figure 5. Locations of instrumented steel straps.

A plan view of the Lindquist Bridge is shown in Figure 5, where each precast deck panel has three steel straps. Electrical resistance strain gauges were installed on two transverse steel straps near mid-span and labeled S7 and S9, respectively.
