# IRT survey for the quality control of FRP reinforced r.c. structures

by P. Corvaglia\*, A. Largo\*

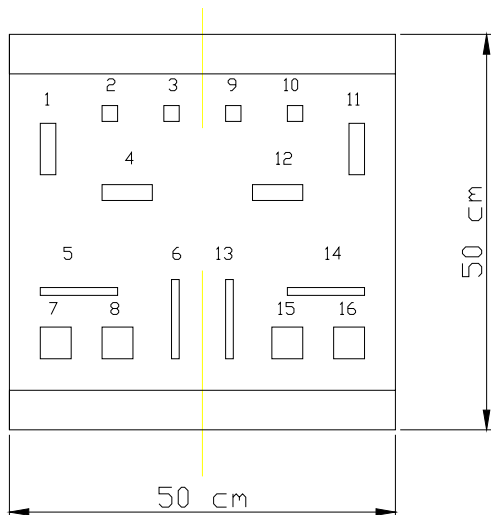
Two types of defects with different dimensions were imposed (see Fig. 1):

- delaminations (by the interposition of two bonded Teflon foils)
  - defects n° 5 and n° 6 (100 mm x 10 mm);
  - defects n° 1 and n° 4 (65 mm x 20 mm);
  - defects n° 7 and n° 8 (40 mm x 40 mm);
  - defects n° 2 and n° 3 (20 mm x 20 mm);

- lack – of – bonding of the FRP (by a simple Teflon foil)
  - defects n° 13 and 14 (100 mm x 10 mm);
  - defects n° 11 and 12 (65 mm x 20 mm);
  - defects n° 15 and 16 (40 mm x 40 mm);
  - defects n° 9 and 10 (20 mm x 20 mm).

**Fig. 1** Imposed known defects

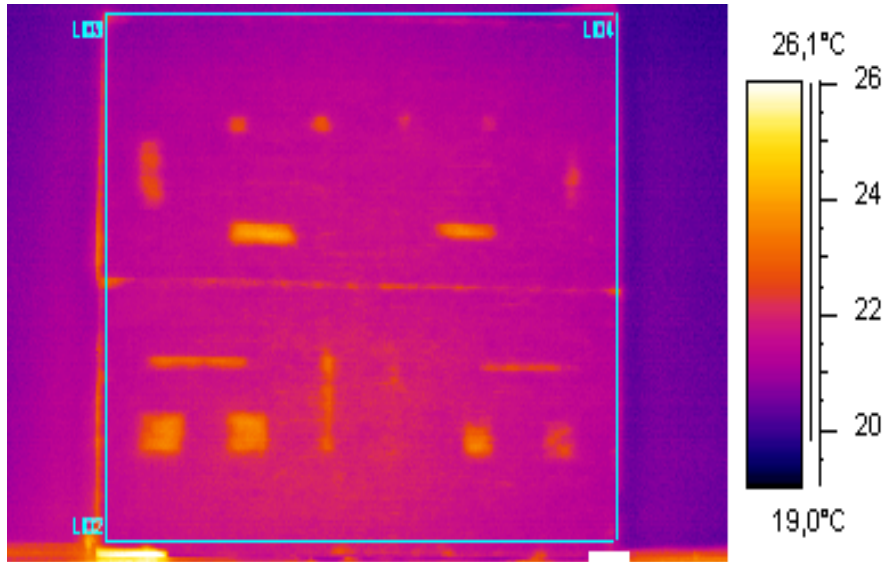
Thermographic data were processed with Almond's half maximum contrast method; a typical thermogram of the CFRP – reinforced sample is presented in Fig. 3. The investigated parameters were the "impulsive heating" time (HT) and the Time of Observation (TObs). Partial results are reported in Fig. 4 related to defect n° 3.

**Fig. 3** Thermogram of the CFRP sample with imposed defects

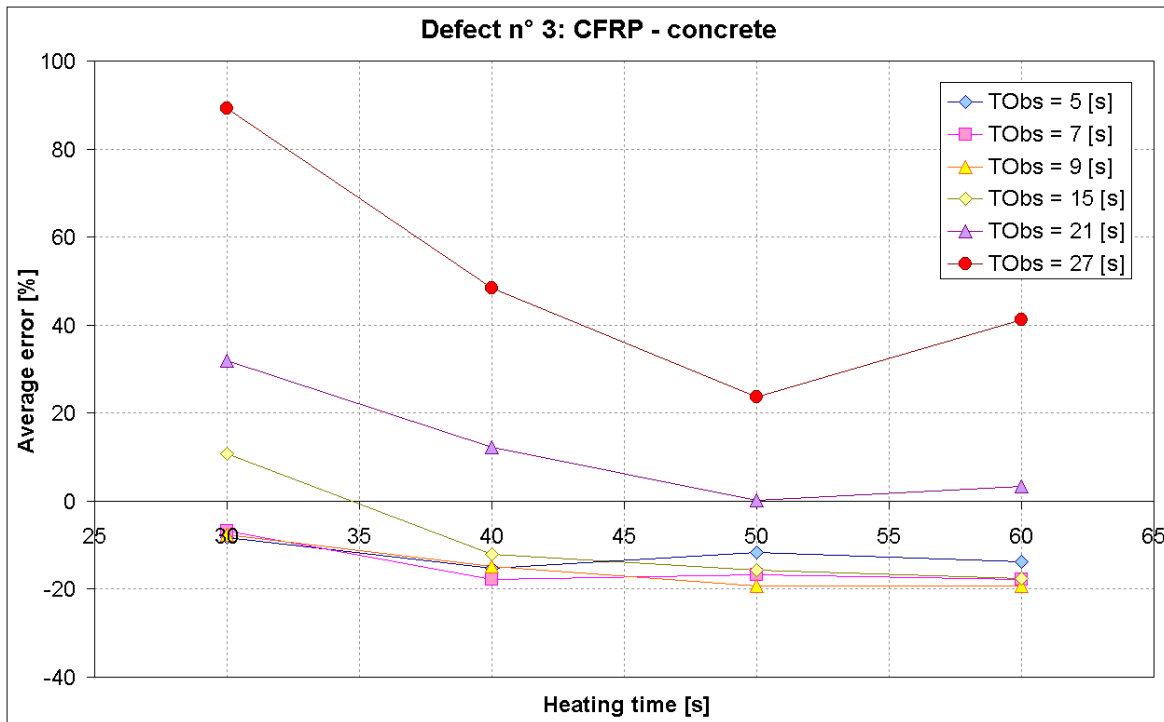
**Fig. 4** Percentage error in the assessment of defect n.3 for different experimental set-ups

1. the error (defined as the ratio between the difference of the estimated and the real number of pixels relative to a defective area, and the real number of pixels relative to the same defective area) increases with increasing TObs;

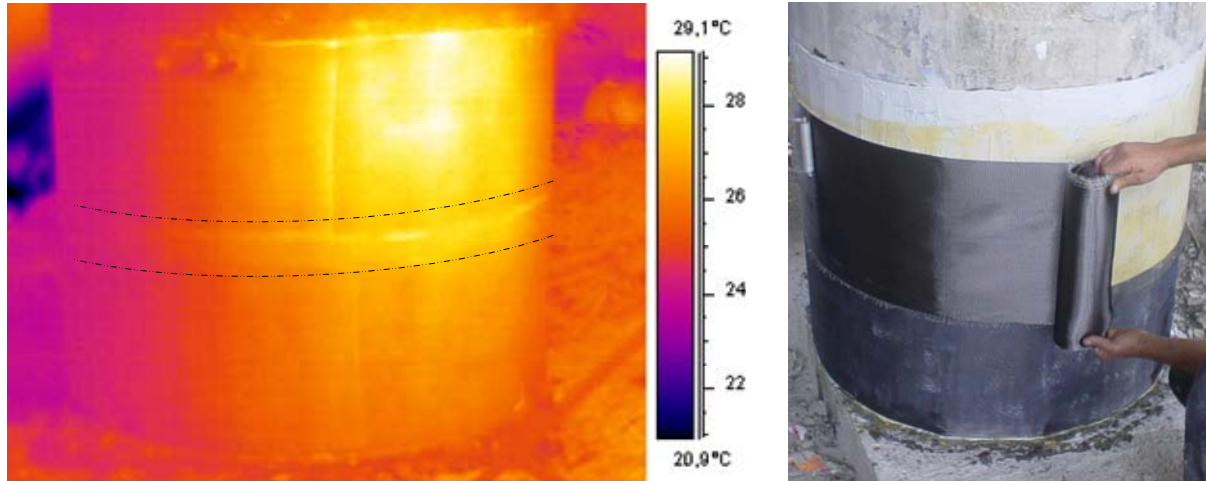
The first type (in white square in Fig. 7) is caused by the longitudinal joining of two CFRP sheet. When applying multiple plies of FRP sheets for columns wrapping, or when two strips need to be joined longitudinally, it is necessary to create an overlapping of at least 20 cm. Overlapping is not necessary for the width of the fabric because the different strips of fabric can simply be applied one next to the other. Nevertheless, for the presented case study, the strategy of overlapping the two CFRP strips, along the width, for 3 cm, was adopted (this is also evidenced in Fig. 8). According to the IRT survey results, it can be concluded that this kind of approach can cause a “step effect” resulting in a lot of air inclusion all along the column diameter. However, these kind of defects are very often characterized by a low aspect ratio and can be easily repaired using low – pressure epoxy injection.

**Fig. 8** CFRP strip transversal overlapping
