STRUCTURAL HEALTH MONITORING OF GFRP REINFORCED BEAM AT VETERAN AFFAIRS BROOKSIDE CEMETERY

Abstract

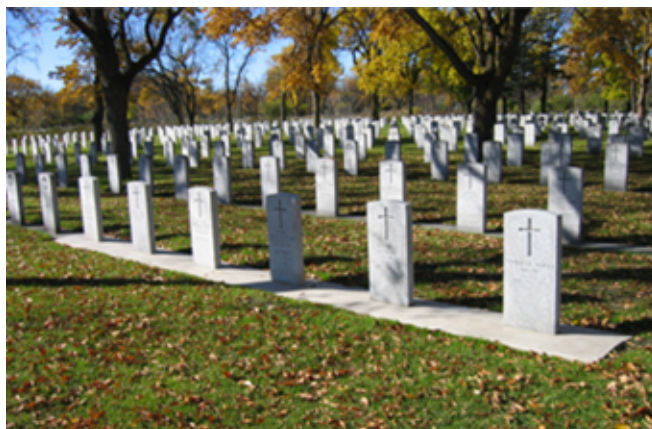
Figure 1. GFRP reinforced concrete beam at Brookside Cemetery

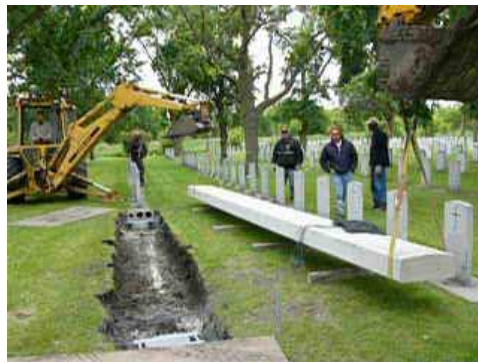
The instrumented GFRP reinforced concrete beam was installed at Brookside Cemetery on August 26, 2004. Two backhoes with chains and straps were used to lift the beam on each end and place it on the existing concrete piles (Figure 5). During this process, the sensors installed in the beam were monitored and strains of up to $200 \mu\epsilon$ were recorded while nominal strains were observed at the support sections.

Figure 5. Installation of reinforced concrete beam on piles
