## I40-Bridge, New Mexico, USA

### Project Description:

The I40-Bridge over the Rio Grande was part of the Highway "Interstate 40" in New Mexico. In the 1960's and 1970's over 2500 bridges were built in the U.S. with a design similar to this on Interstate 40. These bridges were built without structural redundancy and typically had only two plate girders carrying the loads. Failure of either girder was assumed to produce catastrophic failure of the bridge; hence these bridges were referred to as fracture-critical bridges. The US-Federal Highway Administration (FHWA) and the National Science Foundation (NSF) have provided funds for evaluation and testing of the existing fracture critical bridges over the Rio Grande. The investigation was conducted by the structural dynamics group around Dr. C.R. Farrar of the Los Alamos National Laboratories.

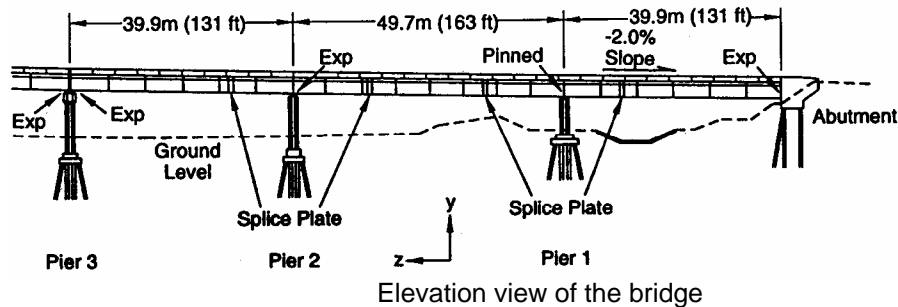
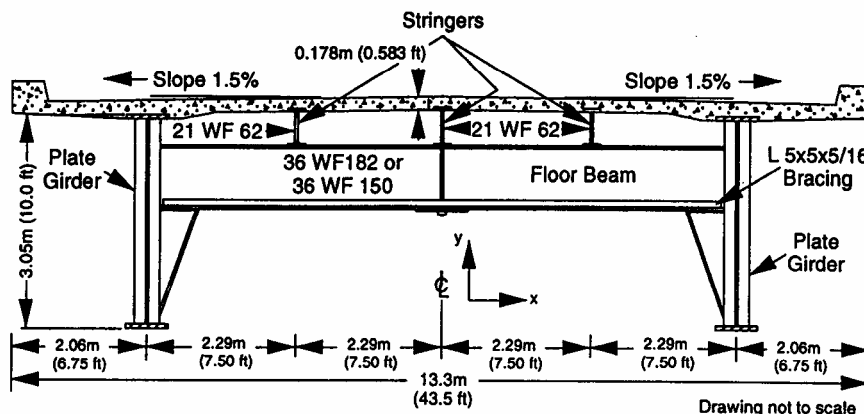
The I40-bridge consisted of two separate spans for each traffic direction divided in three identical, structural nearly independent sections, respectively. Each section was made up of three spans, see Fig. “Elevation view” which shows one section. The bridge was made up of a concrete deck supported by two plate girders and three steel stringers. The loads from the stringers were transmitted to the plate girders by floor beams, see Fig. “Cross section of the bridge”.

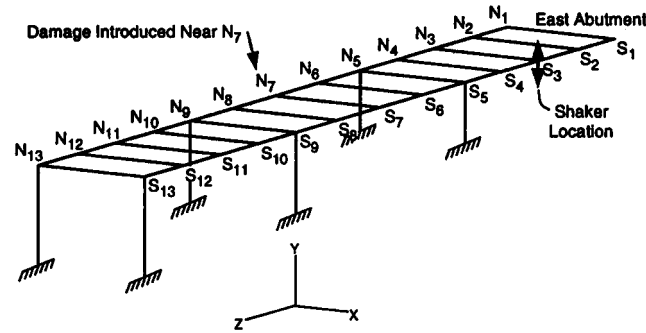
Type of sensors	Number	Location
Acceleration	26	N1-S13, see Figure below
Force	1	Shaker, see Fig. below

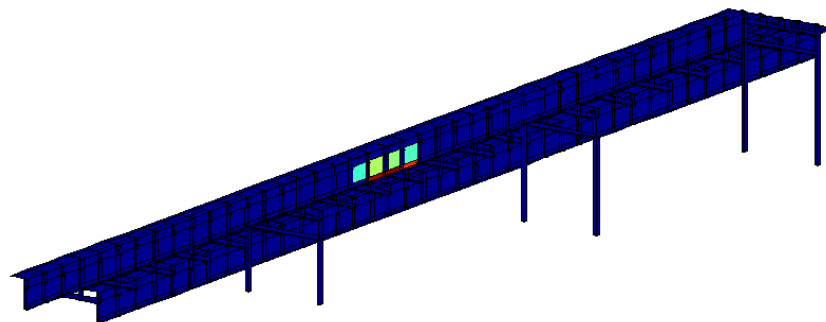
The damage could be detected, localized and quantified by means of an inverse eigensensitivity approach and Frequency Response Function (FRF) approach (alternatively) combined with parameter selection and regularization techniques.
