FIELD CONDITION MONITORING OF WATER MAINS IN THE CANADIAN PRAIRIES

Abstract

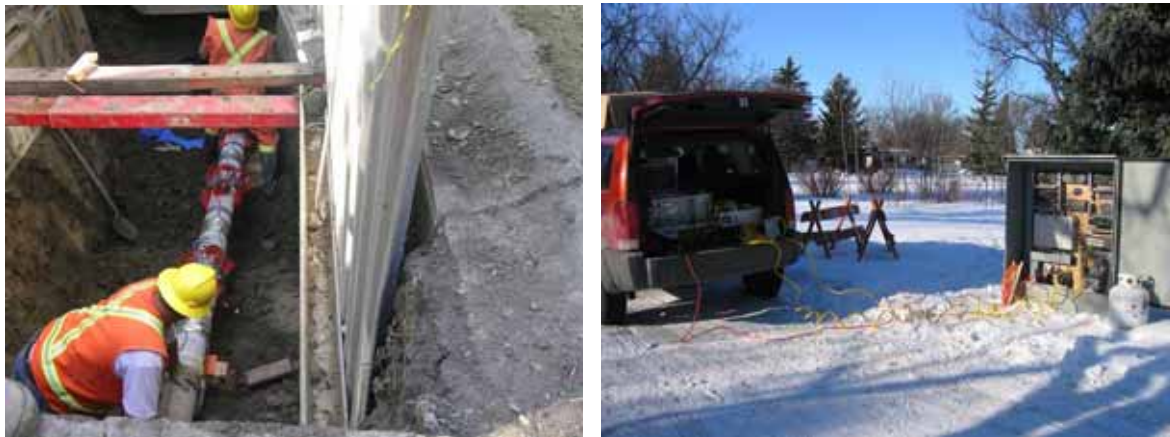
Field installation was carried out between September 11, 2006 and September 15, 2006. A trench, 2.5-m-wide, 5.9-m-long and 2.6-m-deep was excavated (Figure 1) and the existing AC pipe section, which was 2.2 m below the ground surface, was removed. Installation of instrumented section of pipe and sensors was carried out at different levels below the ground. The external instrumentation box is shown in Figure 2.

Figure 1. Installation of Instrumented AC Pipe Section Figure 2: Data Acquisition System.

A CR1000-55 data-logging system from Campbell Scientific Inc. was installed to collect the data from the electrical strain gauges. The data-logging equipment is housed on-site in a metal instrumentation box installed 1.2-m north of the trench (Figure 2). Readings are recorded hourly from these sensors. The FOS DAQ consists of IDERS SHM 5100-A for the FBG sensor, and FOX-TEK FTI-3300 FT for the long-gauge strain sensors. FOS readings are taken periodically every other month for a period of approximately 1 hour.

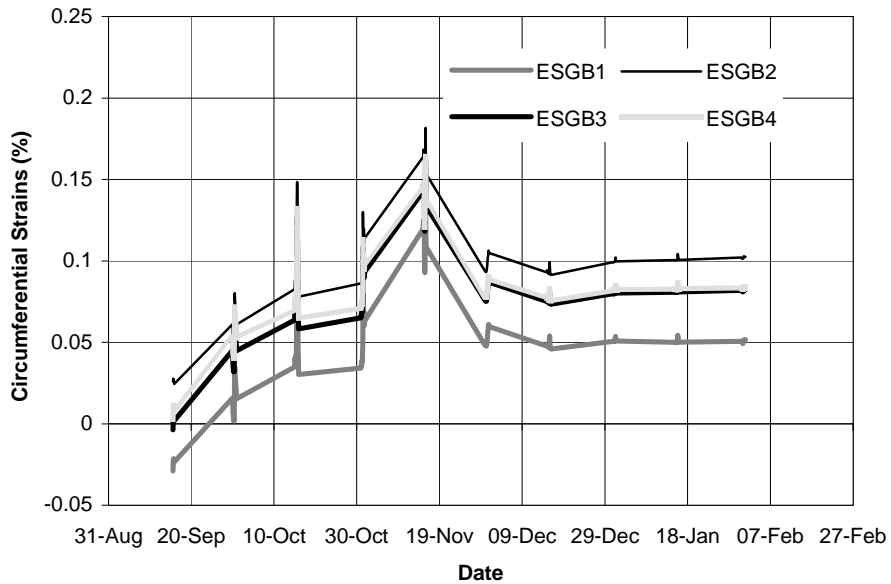
Figure 5. Circumferential Strains versus Time at Section B-B.

Figure 5 shows the measured circumferential strains at the midspan. Similar to the longitudinal strains, the pipe experienced a significant increase in circumferential strain until mid November and then has attained steady state in the range 0.05 and 0.1%. Spikes similar to that of longitudinal strains are notable. The decrease in spikes' magnitude is suggesting that the backfill soil has compacted with time providing better confinement to the pipe. The circumferential strains at the other cross-sections show a similar pattern.

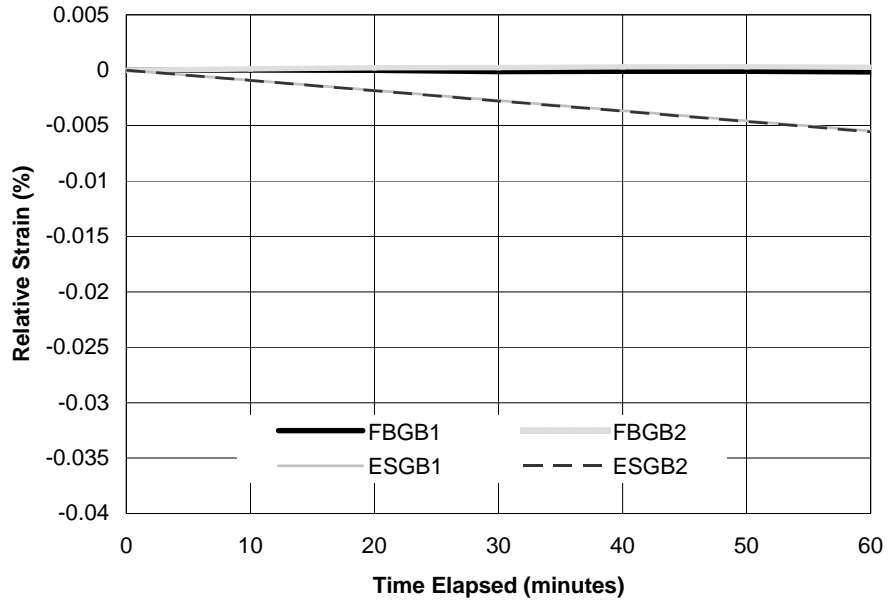
Figure 8. Comparison of FBG and ESG Strains at Section B-B on January 23, 2007 (15h00-16h00).

Figure 8 shows relative longitudinal strains recorded on 23 January 2007 for an hour by the ESG and FOS installed at Section B-B. Since ESG strain measurement is taken every hour, two values are joined to form the straight lines for ESGB1 and ESGB2. For the FBG sensors, a higher sampling rate was used. The two instruments measure similar strains, and in this case the difference of 0.005% is insignificant. The relative change of strain values measured by ESG and FOS will be observed during the monitoring process.

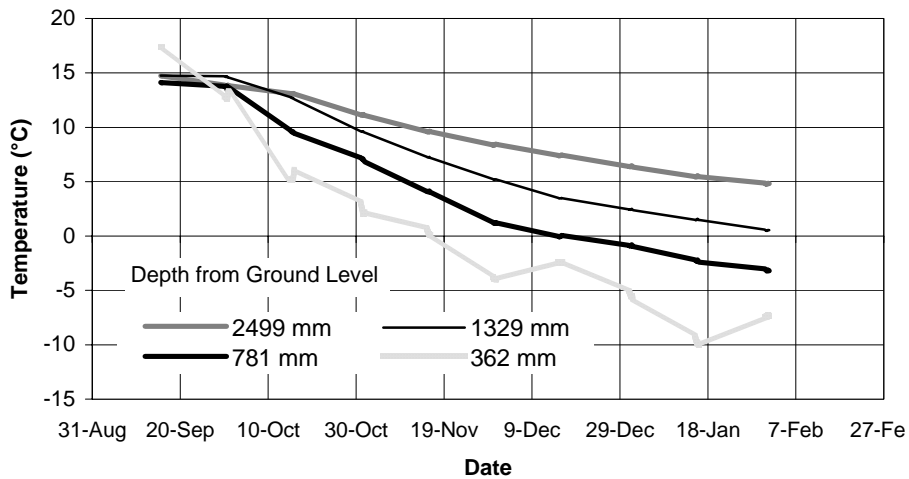
Figure 9. Temperature versus Time at Different Levels in Trench.

Figure 9 shows the average temperatures recorded from some of the thermocouples located at different depths throughout the trench between September 2006 and January 2007. The results show high variation in temperatures closer to the ground surface. At pipe level and below, the temperature dropped at a fairly stable rate but did not go past the freezing point.
