## STRUCTURAL HEALTH MONITORING OF AN INSTRUMENTED BUILDING IN MEXICO WITH ACCELEROMETERS AND GPS SENSORS

### ABSTRACT

This paper presents the most significant results of the structural response of an instrumented building in Mexico during eight seismic events recorded between 2011 and 2013. A criterion for assessment of the structural health is proposed and the advantages of an automatic post-event structural warning system are discussed. The estimation of structural condition is based on five indicators: two related to intensity (peak ground acceleration and Arias intensity) and three related to structural response (interstorey drift ratio, seismic coefficient and percentage change in the fundamental frequencies corresponding to the horizontal components). When the structure is subjected to an earthquake, the records are analysed by the warning system and a report is generated automatically. Changes in structural features can be detected and compared to their initial values to establish their state of damage

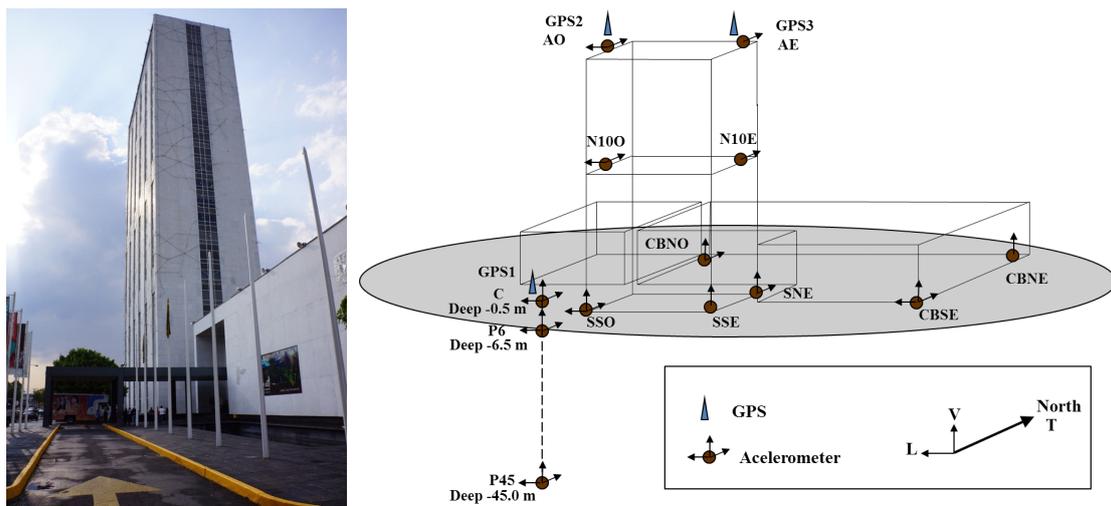
Figure 1. Overview of the building and instrumentation

The studied building is appreciated as representative of the architecture of Mexico City in the 1960's (Figure 1), the north side is adjacent to the archaeological site of Tlatelolco. The building consists of a 22-storey tower and three low-rise structures. The four components of the building share a common basement. Since 1964, when the building was inaugurated, the building exhibited several problems. The tower had differential settlement and tilting, and uplifting of the low-rise structures.

The seismic instrumentation in the building, operating since December 2008, consists of a network of 28 high-resolution uniaxial force balance accelerometers (Kinematics) located in different points of the building and the surrounding ground, as show in Figure 1. The resolution used to monitor the structural response is adequate for recording a broad range of excitation levels (such as ambient vibration and high-intensity earthquakes). In May 2009, a GPS system (Leica) was installed; this system is composed of a fixed base station (GPS1) and two antennas (GPS2 and GPS3) on the roof of building to monitor the verticality. Starting in August 2011, the GPS system has been operating in parallel with a logging system that records signals from accelerometers, enabled to directly measure the relative displacement at the roof with respect to its reference base station.

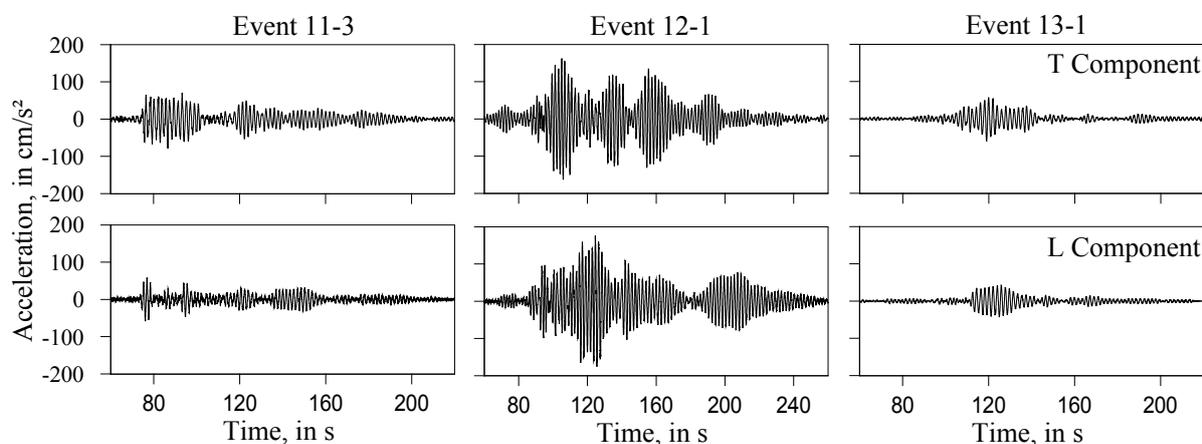
Figure 2. Time-histories of the NE corner roof acceleration of the building

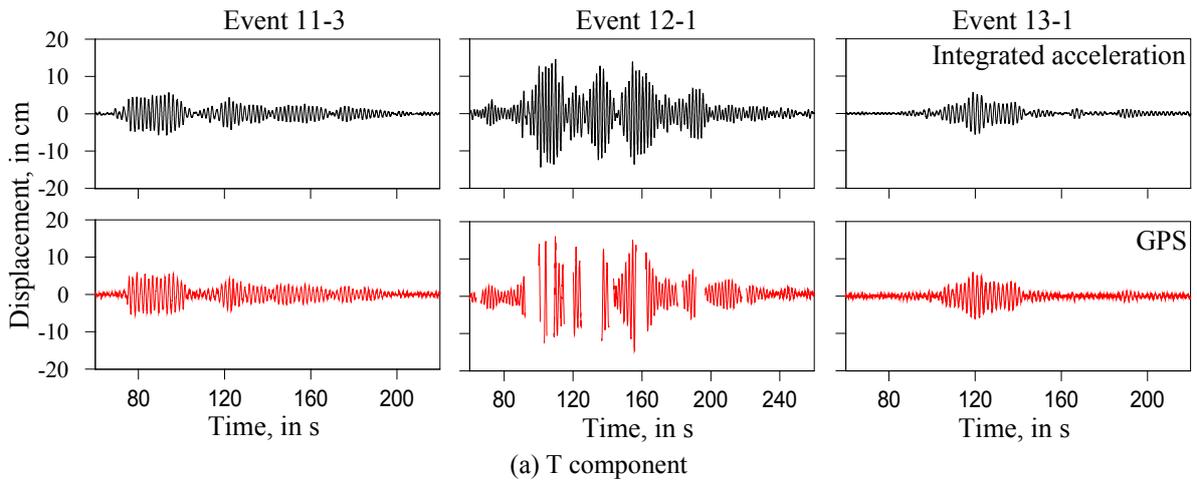
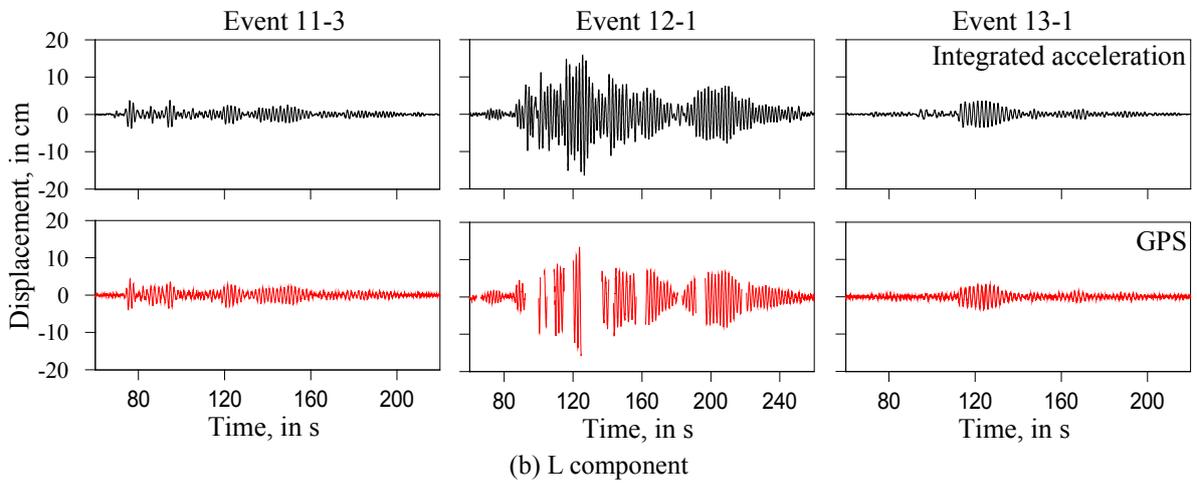
Figure 3. Comparison of time-histories of the NE corner roof displacement's measured with GPS and double-integrated acceleration

Table 3 summarizes the peak accelerations and displacements of the earthquake records of roof level. In all events the displacements computed by integrating the acceleration records and measured with the GPS system are very similar. The maximum accelerations and relative displacements in the L direction were  $176.3 \text{ cm/s}^2$  and 16.5 cm, and in T direction  $163.0 \text{ cm/s}^2$  and 14.6 cm during the event 12-1. Figure 2 shows the time-histories acceleration at the NE corner roof of the building during the 11-3, 12-1 and 13-1 events. Similarly for those events, in the Figure 3, the histories of relative displacement measured with GPS units in the roof with respect to its reference base in ground floor, and those computed from the accelerograms are compared. These displacement histories show that the GPS data recorded during smaller and moderate events have a good performance except for event 12-1.

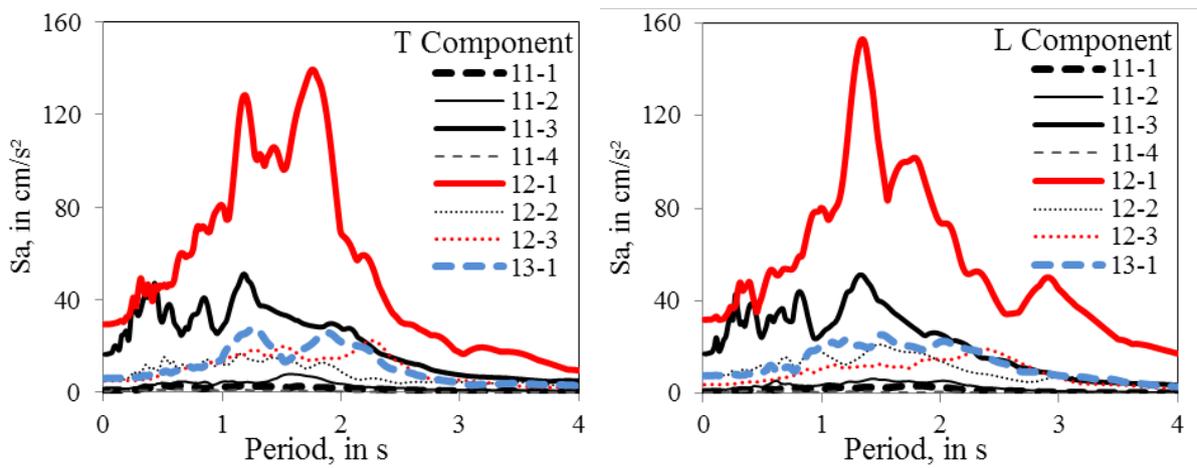
Figure 4. Comparison of response spectra were calculated with the records of the field-surface site

Response spectra for the eight seismic events in the L and T components, for 5 % of critical damping, are shown in Figure 4. The highest spectral ordinates correspond to the most intense events that have been recorded (11-3 and 12-1). Figure 4 clearly shows the distinct intensity of all seismic events. The dominant long periods

A spectral analysis was applied to the seismic records listed in Table 1. Figure 5 shows the estimated Fourier spectral ratios between the roof and field sites motions obtained to illustrate the variation of the fundamental frequencies of the L and T components. The shapes of the curves and the intervals of maximum amplitudes vary from one event to another. Furthermore, for some events more than one peak appeared. This suggests that the system exhibited nonlinear behavior during these seismic events. This is clearly noticeable in event 12-1. As a consequence, during event 12-1 the building suffered a reduction of 16 and 6 % of fundamental frequency in L and T components with respect to the first event 11-1 recorded after its rehabilitation. The reduction of stiffness in the building was estimated as well. The values of stiffness loss were 30 and 12%, while the interstory drifts averaged 0.20 and 0.14% for the L and T directions, respectively. It has been found that dynamic properties of the building are sensitive to the intensity of the ground motion. The variation of structural parameters of the system can be attributed mainly to different non-linearity sources of the structure. The identified fundamental frequencies in L and T components are included in Table 3. This frequencies or vibration periods of the building fall within the interval where the dominant periods of the site is located (Figure 4).

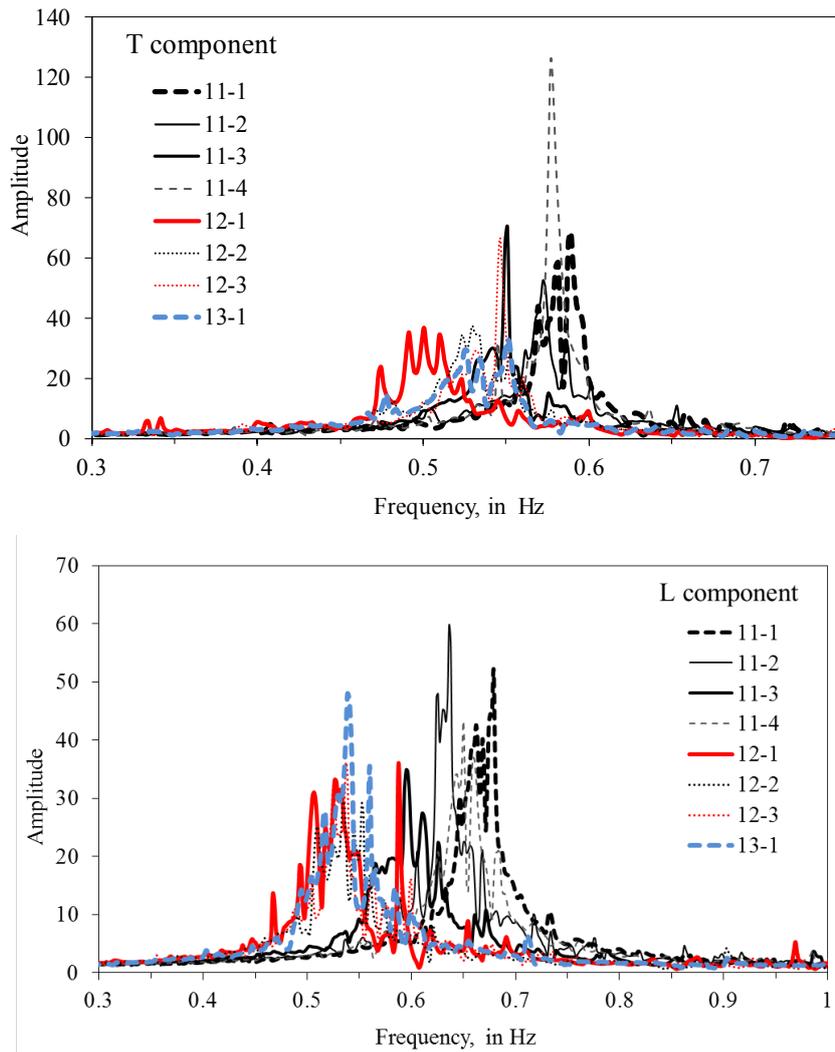
Figure 5. Estimated Fourier spectral ratios between the motion at roof and at field site
